E.4 KORUMBURRA TOWN CENTRE STREETScape MASTER PLAN - ADOPTION

Korumburra Town Centre Streetscape Master Plan

Concept Stage Road Safety Audit

Final – 06/04/2016

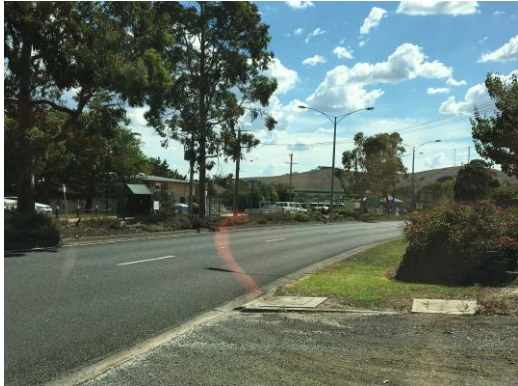
No	Audit Findings	Audit Recommendations	Risk Rating	Client Response	
				Accept: Yes/No	Reasons / Comments
2	<p>On page 8, item 6, the crossover servicing the Korumburra Rail Yards, is proposed to be set forward as part of the Town Centre gateway treatments. It is not clear the frequency and type of vehicles accessing this crossover. During the audit however, it was observed that some trucks were using this crossover.</p> <p>No swept paths analysis was provided at this location and it is not clear what the reduced road width would have on vehicular swept paths. Consequently, vehicles accessing this crossover may collide with the proposed new trees.</p> <p>The proposed new trees located immediately to the northwest and southeast of the rail yard's crossover impedes on sight lines, for vehicles exiting from the rail yard and the proposed parking lots directly to the southeast.</p> <p>The trees appear to be within the clear zone requirement.</p>

<p>Consider removing/relocating these trees such that they don't effect sight lines.</p>	<p>Likelihood: Occasional</p> <p>Severity: Serious</p> <p>Risk Rating: MEDIUM</p>	Yes	<p>Swept path assessments (refer to attached) has been conducted at this crossover using the 12.5 metre long heavy rigid vehicle, and it was found that trucks are able to turn into and out of this road with adequate clearances.</p> <p>All trees will be set back at least 1 metre from the kerb in accordance with VicRoads Tree Planting Policy Guidelines, to provide adequate sightlines for vehicles exiting from this road onto South Gippsland Highway.</p> <p>Note that Master Plan text covers this.</p> <p>Sealing the road will be considered as a separate future project.</p> <p>Note: this is VicTrack owned land -Council leases it from VicTrack.</p>

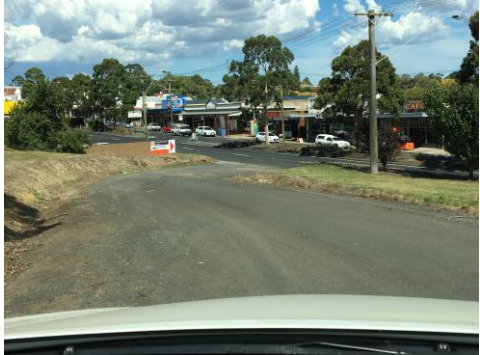
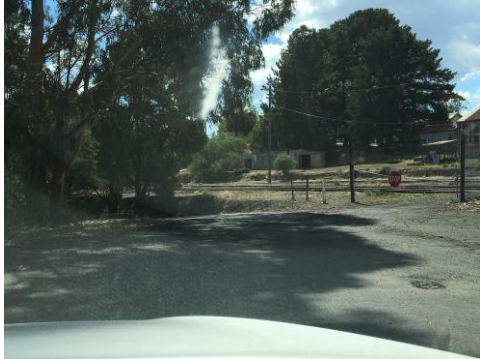
No	Audit Findings	Audit Recommendations	Risk Rating	Client Response	
				Accept: Yes/No	Reasons / Comments
3	<p>The crossover servicing the Korumburra Rail Yards also access the Central Plaza carpark. Given the alignment and grade its use to access the carpark should not be promoted. Furthermore if it continues as the main access to the rail yards consideration should be given to widening the road and providing better delineation such as linemarking and curve alignment markers.</p>

<p>Consider reconstructing the road servicing the Korumburra Rail Yards and providing better delineation.</p>	<p>Likelihood: Occasional</p> <p>Severity: Minor</p> <p>Risk Rating: LOW</p>	<p>Yes</p>	<p>Consider seal and delineation marking as a separate future project.</p> <p>No change to Master Plan as not changing existing conditions.</p>

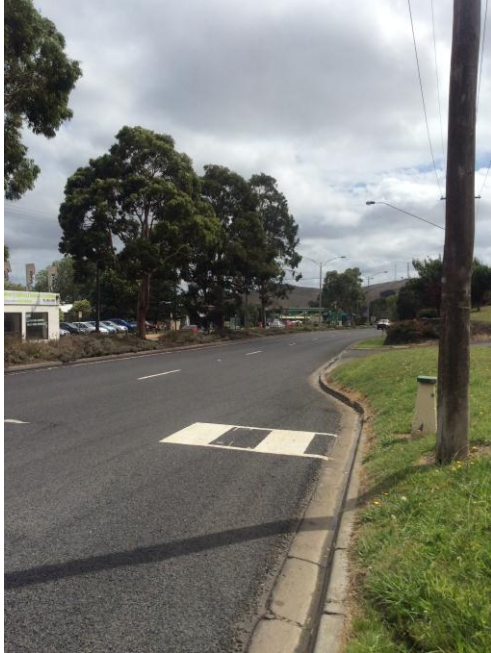
No	Audit Findings	Audit Recommendations	Risk Rating	Client Response	
				Accept: Yes/No	Reasons / Comments
5.4	<p>It is noted that during the audit it was observed that buffers in between parking bays, which appear similar to zebra-crossings are generally located near/in-line with the informal pedestrian crossing. They could be mistaken by pedestrians for zebra crossing and consequently attempt to cross in the expectation that drivers will stop. Further, it is envisaged that parked vehicles will encroach onto this space, blocking pedestrian access onto the footpath.</p>

It is recommended that these are not reinstated.	<p>Likelihood: Improbable</p> <p>Severity: Serious</p> <p>Risk Rating: MEDIUM</p>	Yes	Replace with alternative type of marking that does not mimic a pedestrian crossing marking, to indicate location of, and no parking area adjacent to, a fire hydrant.

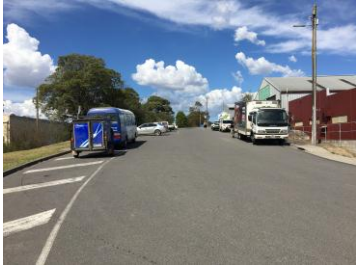
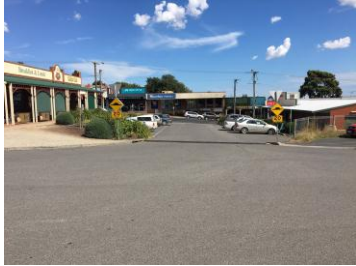
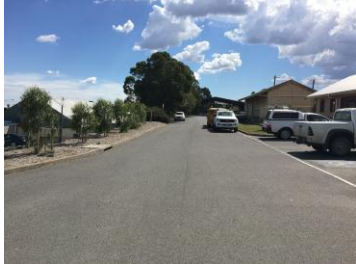
No	Audit Findings	Audit Recommendations	Risk Rating	Client Response	
				Accept: Yes/No	Reasons / Comments
13	<p>The unnamed road parallel to Commercial Street to the northeast servicing the Central Plaza has no lane discipline or control features It is not clear if it's intended as a one-way or two-way road or who gives way at the junction to the back of Kelly's Bakery.</p>

Provide better delineation via linemarking and signage.	<p>Likelihood: Occasional</p> <p>Severity: Limited</p> <p>Risk Rating: LOW</p>	Yes	<p>Better delineation to be provided.</p> <p>Master Plan text to be modified.</p>

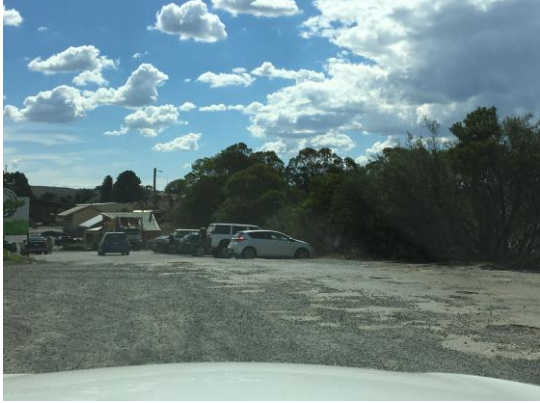
No	Audit Findings	Audit Recommendations	Risk Rating	Client Response	
				Accept: Yes/No	Reasons / Comments
14	<p>Further to Item 14 the northeastern road accessing the Central Plaza carpark is in poor condition with the pavement showing signs of significant cracking.</p>

Resurface the access road.	<p>Likelihood: Occasional</p> <p>Severity: Limited</p> <p>Risk Rating: LOW</p>	Yes	Already proposed to be resurfaced. See Item 24 on page 9 concept plan in Master Plan.
15	<p>The sight lines from the northeastern road accessing the Central Plaza carpark at Bridge Street (north) appears restricted by the bridge alignment and an electricity supply pole.</p>

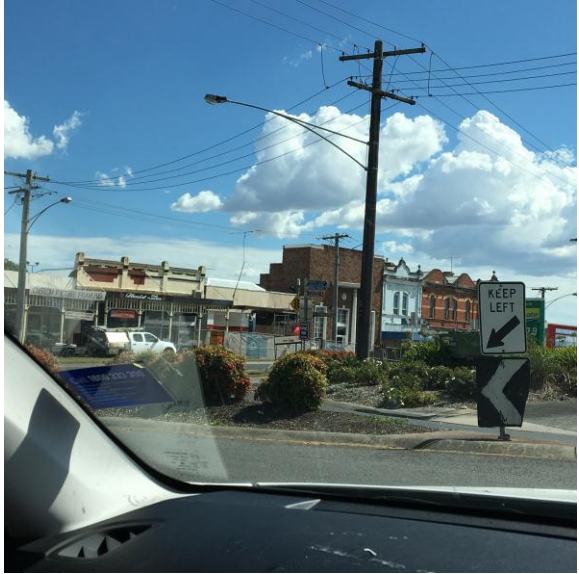
No	Audit Findings	Audit Recommendations	Risk Rating	Client Response	
				Accept: Yes/No	Reasons / Comments
16	<p>The sight lines from South Railway Crescent to left traffic entering Bridge street (northeast) are restricted plantings in the median island and verge. In the north corner of the Bridge Street (northeast) / Commercial Street intersection.</p>

<p>Review sight triangle and ensure proposed plantings do not grow to height that restrict visibility out of South Railway Crescent</p>	<p>Likelihood: Occasional</p> <p>Severity: Serious</p> <p>Risk Rating: MEDIUM</p>	<p>Yes</p>	<p>Appropriate planting will be installed.</p> <p>(Master Plan concept plans to be modified on pages 9 & 15).</p>

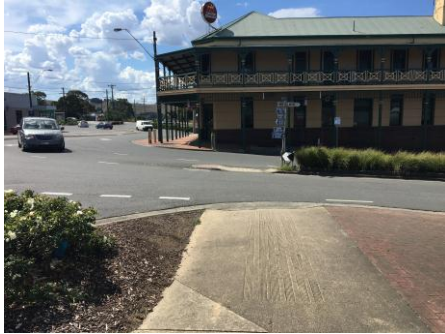
No	Audit Findings	Audit Recommendations	Risk Rating	Client Response	
				Accept: Yes/No	Reasons / Comments
17.6	<p>The Austral Hotel is located on the eastern quadrant of the Commercial Street/Bridge Street (southeast) intersection. Desire lines for pedestrians arriving from the southeast are expected to be directly at the intersection and seem to be in line with the existing pedestrian crossing southeast of Bridge Street which has been removed from the Masterplan.</p>

Review pedestrian volumes and consider access across Commercial Street.	NOTE ONLY	Yes	This can be considered as a separate, future project.

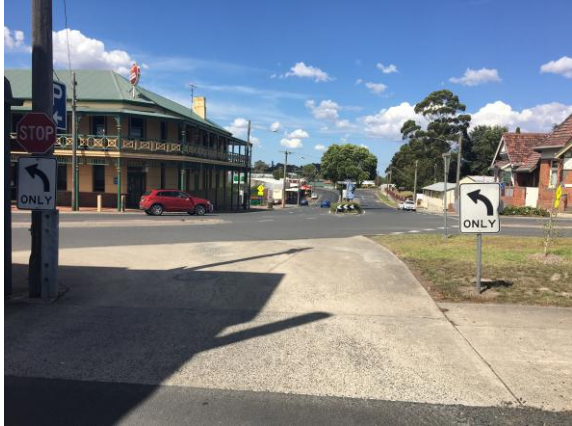
No	Audit Findings	Audit Recommendations	Risk Rating	Client Response	
				Accept: Yes/No	Reasons / Comments
18	<p>Little Commercial Street intersects Commercial Street and Bridge Street at an obscure angle. Although access from Little Commercial Street is currently restricted to left turn only, it has been observed vehicles are ignoring this restriction and travelling straight ahead.</p>

<p>Consider realigning the intersection or installing a traffic island to assist with left run only conformity.</p>	<p>NOTE ONLY</p>	<p>Yes</p>	<p>A traffic island is proposed to assist with left turn only conformity.</p> <p>Master Plan to be modified.</p>

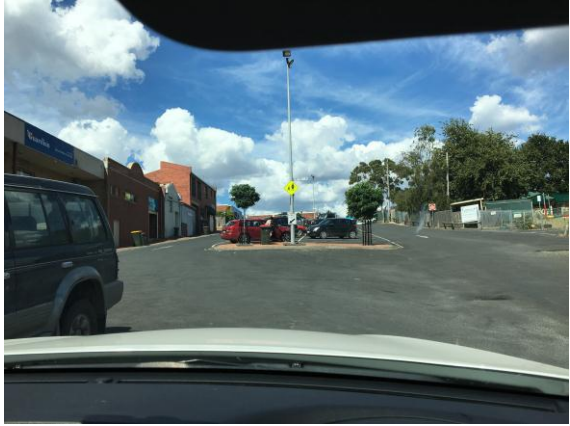
No	Audit Findings	Audit Recommendations	Risk Rating	Client Response	
				Accept: Yes/No	Reasons / Comments
19	<p>The delineation of the carpark along Little Commercial Street in places was confusing. In particular east of Boston Place where parking separated the two direction of traffic.</p>

<p>Consider installing additional line marked arrows and signs to clearly delineate the direction of travel.</p>	<p>Likelihood: Improbable</p> <p>Severity: Limited</p> <p>Risk Rating: LOW</p>	Yes	<p>Not part of the Master Plan Project.</p> <p>The layout and delineation of the Little Commercial St car park and road will be considered as a separate, future project. It was identified as a project by the Korumburra Town Centre Framework Plan.</p>
