2 March 2018

Our ref: 3135925-6400

## **Walkerville Basin Volume Assessment**

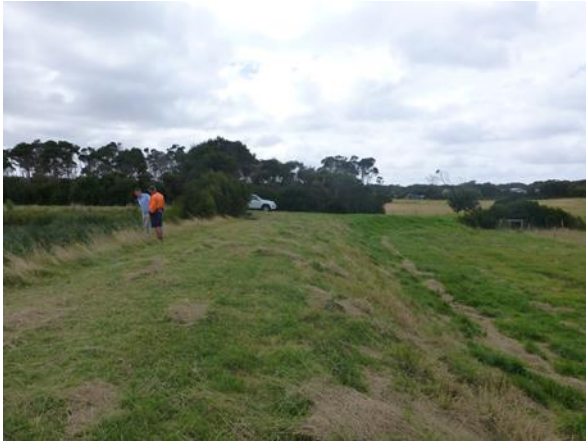
Photo 01

- The water level at the time of the inspection was not provided, but was well below full supply level.
- The condition of the embankments and crest were generally good. Some minor depressions were observed, however, all areas of the crest were accessible and trafficable using a regular light vehicle (Photo 01).

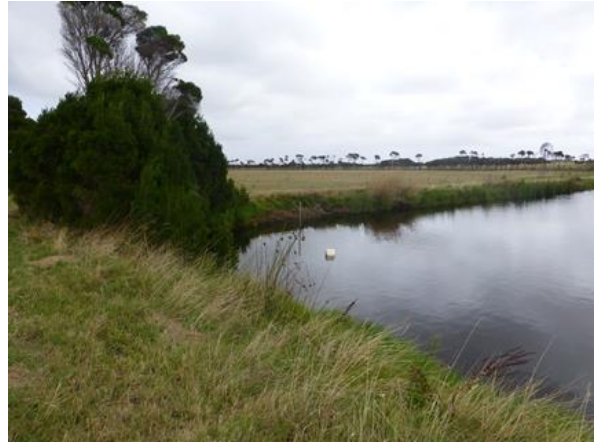
Photo 02

- There were a number of mature trees growing through the embankments. It is recommended trees and shrubs be removed from the embankments to prevent the development of piping pathways via root zones (Photo 02).

- It is understood SGSC have been instructed by the relevant water licencing authority to undertake some minor works to improve the general safety of the basin. These works are to include removal of trees and shrubs from the embankments, placement of road base along the crest to maintain access in all seasons and upgrading the outlet structure to be in line with maximum inflows. These works will also address a number of the items raised in Section 4.

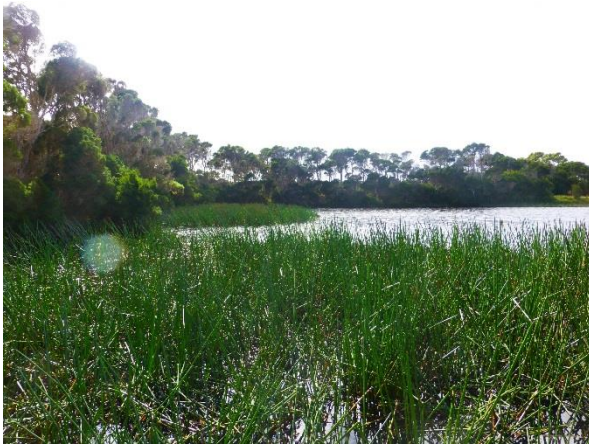
Photo 03

- Heavy reed growth was observed around the basin rim (Photo 03). Vegetation should be managed as it can restrict inflows and outflows.
- Minor cracking and spalling of the concrete overflow structure (spillway) was observed, however the overall condition was generally sound (Photo 04). No visible signs of settlement or leakage around the structure could be observed. However, it was understood that water levels have been low for some time, as such, any possible leakage pathways were difficult to identify.

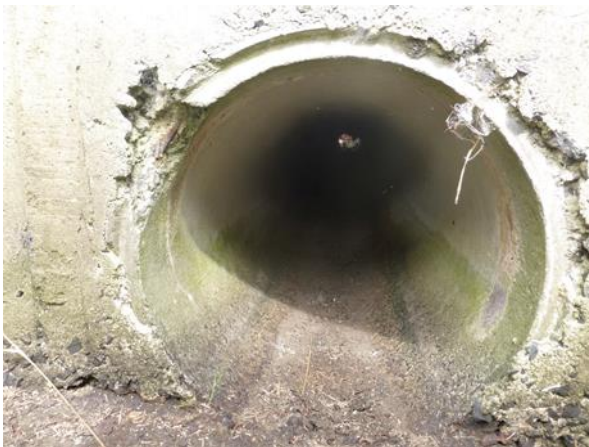
Photo 05

- Despite minor concrete spalling, the general condition of the overflow outlet pipe was sound and clear of blockages (Photo 05).
- Backfilling around the overflow pit was sporadic and not tight against the pit (Photos 06 and 07). This is likely to be affecting the performance of the structure and foundation and may be providing pathways for leakage when water levels are higher than at present.

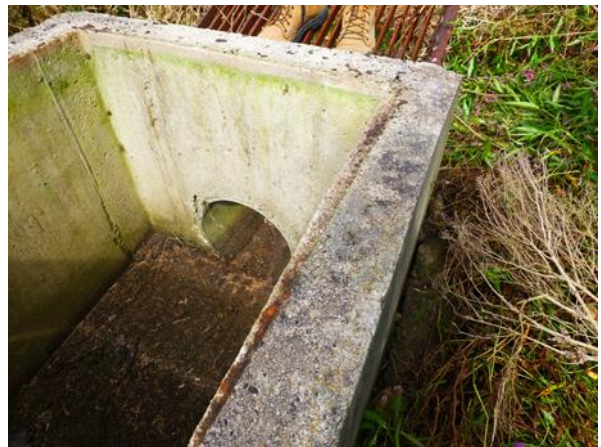
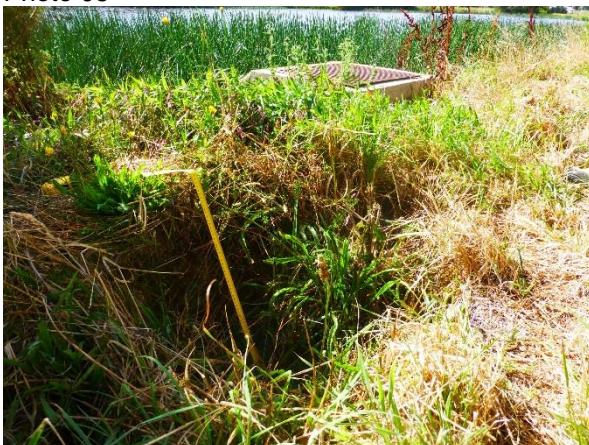
- Backfilling immediately around the overflow structure was sporadic and is likely to be affecting the performance of the structure and foundation. This may lead to leakage around the structure when water levels are higher than observed during the site inspection (hence, a lower full supply level).

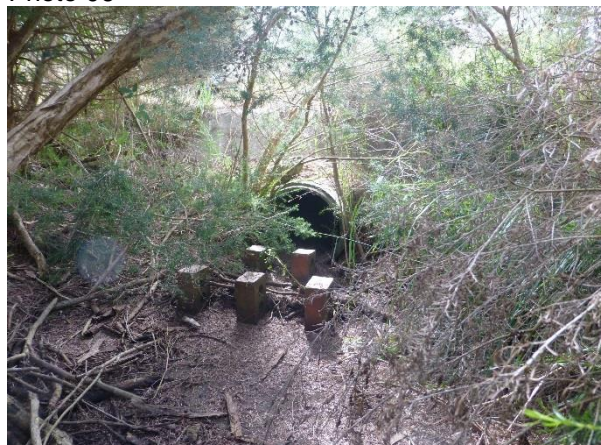
Photo 08

- Downstream, the spillway outlet should be cleared so any flow can pass unimpeded (Photo 08).
- The inlet was below the water line and could not be observed.

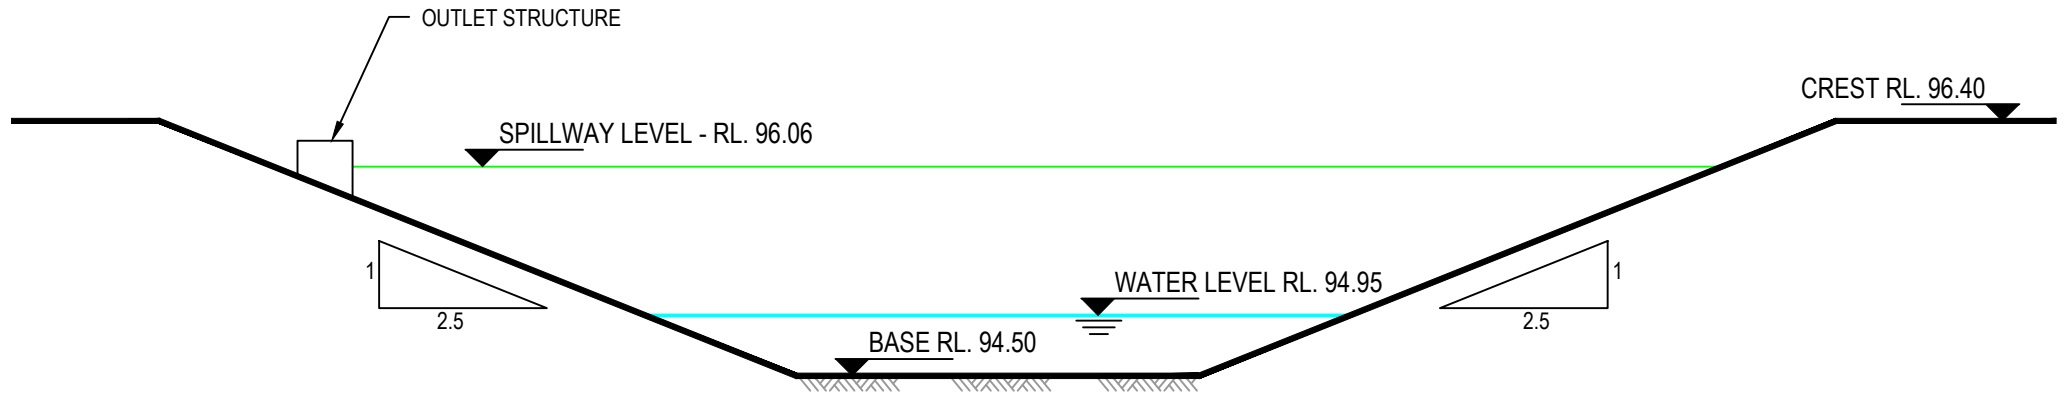
SOUTH GIPPSLAND SHIRE COUNCIL  
 WALKERVILLE BASIN  
 EXISTING CONDITIONS  
 SCHEMATIC

GHD have completed a three-dimensional assessment of basin volume at various water levels using the survey data provided. The results show that at full supply level (FSL) of RL 96.06 m (current overflow level) the maximum storage volume is 13.2 ML (Table 2). Figure SK-01 is a schematic showing basin conditions.

Water Level	Storage Volume (ML)
RL 94.95 m (water level at 27-Jan-16)	3.0
Overflow (spillway) level RL 96.06 m	13.2
RL 96.09 m	13.5
RL 96.28 m (overtopping level)	15.3
