## LGA Dams – Site inspection methodology, general asset information & inspection checklist

<b>Asset name:</b>	Walkerville RB
<b>Locality:</b>	Cnr Grevilla St & Panoramic Dr, Walkerville
<b>Local government region:</b>	South Gippsland
<b>Date of inspection:</b>	23 August 2017
<b>Inspection team:</b>	Ryan Glen, David Roche (SGSC) Greg Branson, Joe Matthews, Richard Mannix (SRW)
<b>Weather conditions:</b>	Cloud with some sun. Windy.
<b>Temperature:</b>	12°C

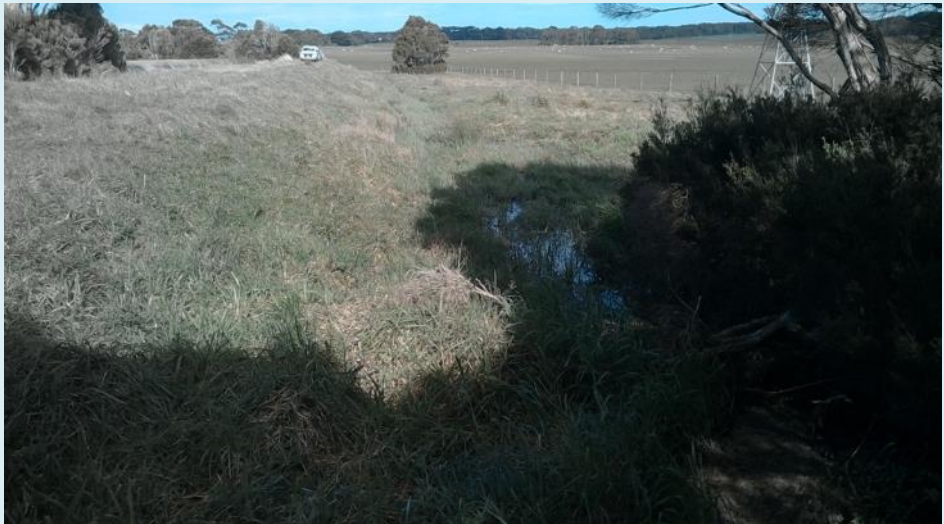
Type	Assessment
Is there a current surveillance program?	No.
Historic surveillance reports reviewed? Details?	None provided.
Has an Emergency Plan or inundation map been provided?	No.
<b>Catchment</b>	
Description	Urban catchment ~0.38 km <sup>2</sup>
Determination from	ArcGIS analysis. Indicative only.
<b>Downstream flood area</b>	
Description	PAR negligible. Breach on southern or eastern side toward dwellings but would attenuate before inundation occurred.
Determination from	ArcGIS analysis and field inspection.
<b>Dam Wall (refer to drawings for more info)</b>	
Construction type	Homogeneous earthfill.
Upstream face type	Homogeneous earthfill.
Downstream face type	Homogeneous earthfill.
Photograph of dam wall

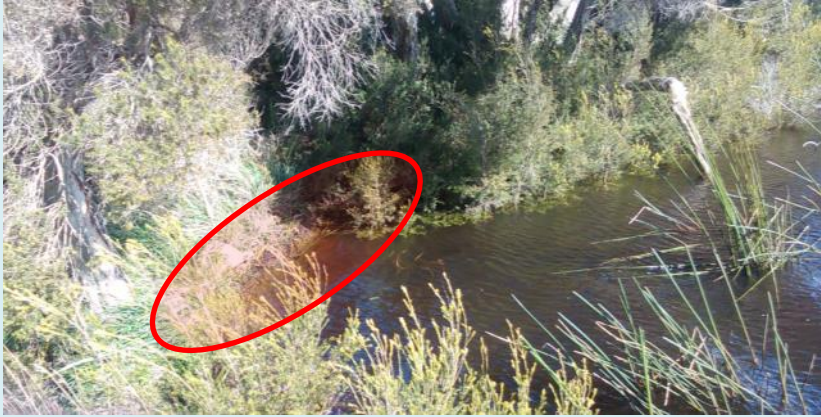
Type	Assessment
Photograph of inlet	Concrete headwall visible only (refer red outline) due to vegetation and storage level at time of inspection.

Type	Assessment <sup>1</sup>	Detail	Recommendation	Urgency Rating <sup>2</sup>	Importance Rating <sup>3</sup>
<b>Inlet works</b>					
General condition	N/A	Not sighted due to storage level at time of inspection.	Remove vegetation around inlet structure.	Short term action	High
<b>Other comments/ observations</b>					
Freeboard and outlet adequacy.		Large rainfall event could cause outlet pit trash screen to block and RB to overtop due to inadequate freeboard causing further damage to embankment and pipework where already compromised at outlet.	See above.
