2 March 2018

Justin Taylor  
Senior Design Engineer  
South Gippsland Shire Council  
9 Smith Street  
Leongatha VIC 3953

Our ref: 3135925-6400

## **Walkerville Basin Volume Assessment**

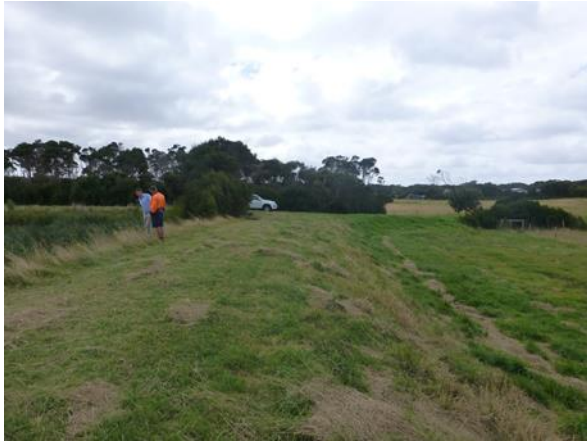
Photo 01

- The water level at the time of the inspection was not provided, but was well below full supply level.
- The condition of the embankments and crest were generally good. Some minor depressions were observed, however, all areas of the crest were accessible and trafficable using a regular light vehicle (Photo 01).

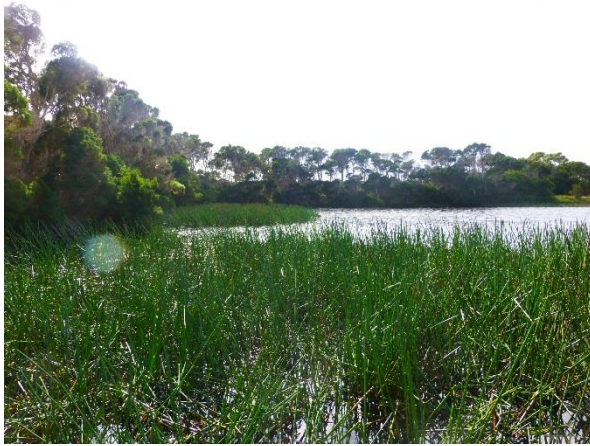
Photo 03

- Heavy reed growth was observed around the basin rim (Photo 03). Vegetation should be managed as it can restrict inflows and outflows.
- Minor cracking and spalling of the concrete overflow structure (spillway) was observed, however the overall condition was generally sound (Photo 04). No visible signs of settlement or leakage around the structure could be observed. However, it was understood that water levels have been low for some time, as such, any possible leakage pathways were difficult to identify.

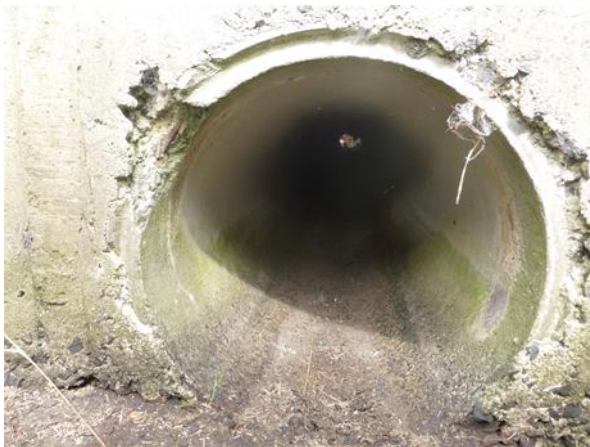
Photo 05

- Despite minor concrete spalling, the general condition of the overflow outlet pipe was sound and clear of blockages (Photo 05).
- Backfilling around the overflow pit was sporadic and not tight against the pit (Photos 06 and 07). This is likely to be affecting the performance of the structure and foundation and may be providing pathways for leakage when water levels are higher than at present.

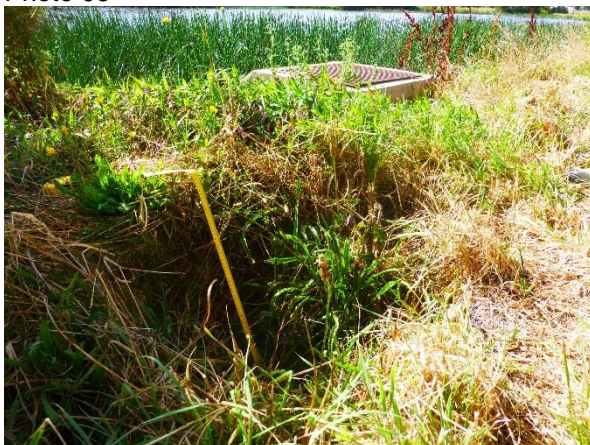
- Backfilling immediately around the overflow structure was sporadic and is likely to be affecting the performance of the structure and foundation. This may lead to leakage around the structure when water levels are higher than observed during the site inspection (hence, a lower full supply level).

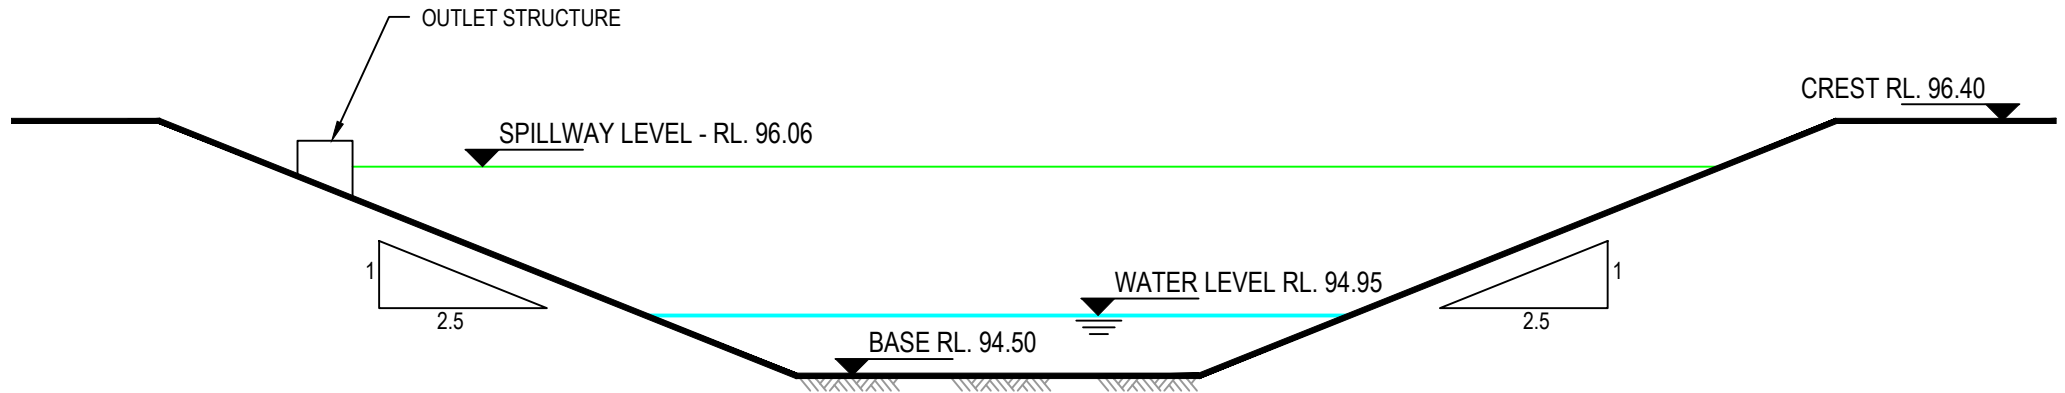
SOUTH GIPPSLAND SHIRE COUNCIL  
 WALKERVILLE BASIN  
 EXISTING CONDITIONS  
 SCHEMATIC

GHD have completed a three-dimensional assessment of basin volume at various water levels using the survey data provided. The results show that at full supply level (FSL) of RL 96.06 m (current overflow level) the maximum storage volume is 13.2 ML (Table 2). Figure SK-01 is a schematic showing basin conditions.

Water Level	Storage Volume (ML)
RL 94.95 m (water level at 27-Jan-16)	3.0
Overflow (spillway) level RL 96.06 m	13.2
RL 96.09 m	13.5
RL 96.28 m (overtopping level)	15.3
