Proposed works at Walkerville Retarding Basin

1.1 We **enclose** by way of service copy of a report of Mr David Stewart – Australian Dams and Water Consultants Pty Ltd dated 30 April 2018.

SOUTH GIPPSLAND SHIRE COUNCIL
WALKERVILLE BASIN
EXISTING CONDITIONS
SCHEMATIC

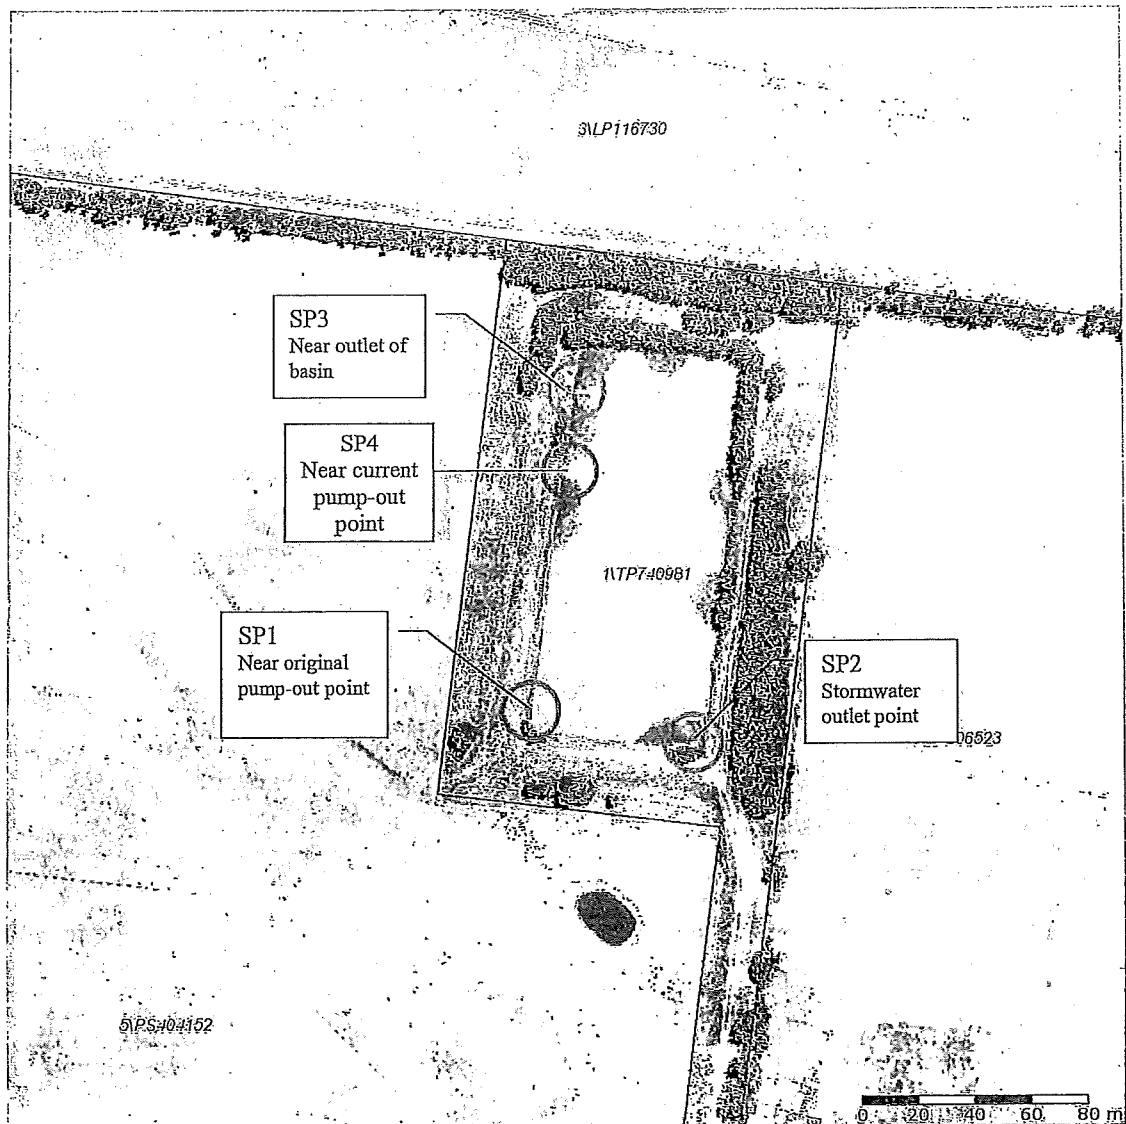
Figure 3-1: Basin sampling locations

The water and sediment samples have been tested for a range of parameters including microbial pathogens, nutrients, salinity and heavy metals. Details are provided in Sections 4 and 5.

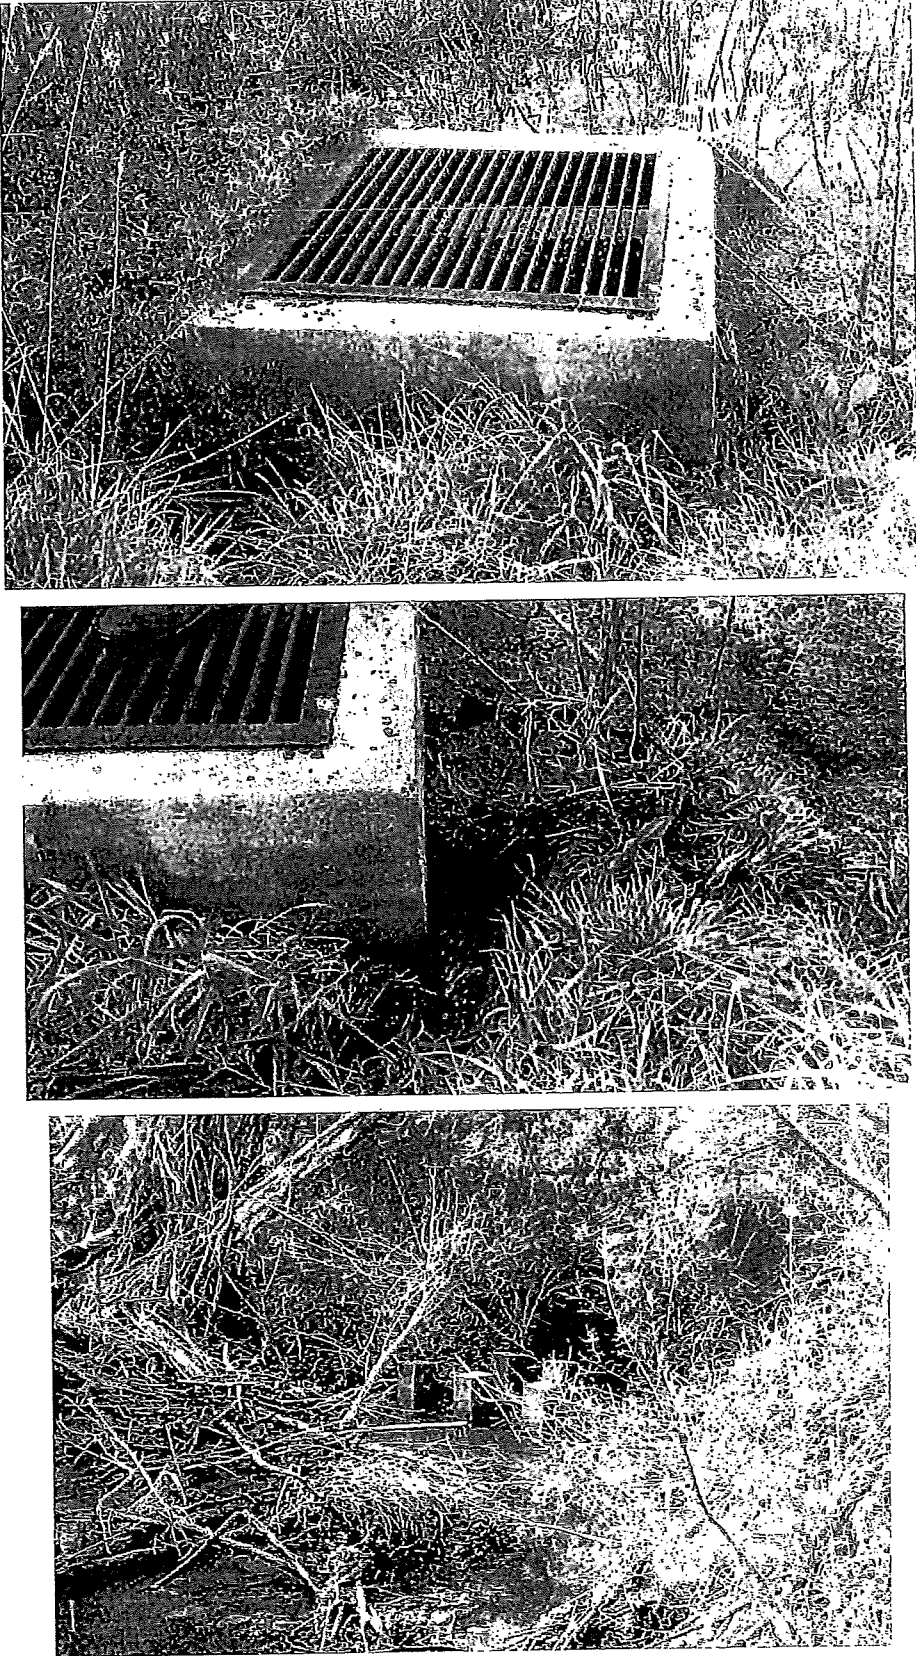
Type	Assessment
Photograph of outlet

General condition	Unsatisfactory	Evidence of break in pipe as flow bypassing outlet discharging through outlet pipe on d/s side.	As above.	As above.	As above.
Discharge point					
General condition	Fair	Discharge point and channel immediately below requires cleaning and regular maintenance.	Refer to recommendations under Spillway and Downstream Toe Area.

Type	Assessment ¹	Detail	Recommendation	Urgency Rating ²	Importance Rating ³
Inlet Works					
General condition	N/A	Not sighted due to storage level at time of inspection.	Remove vegetation around inlet structure.	Short term action	High
Other comments/ observations					
Freeboard and outlet adequacy.		Large rainfall event could cause outlet pit trash screen to block and RB to overtop due to inadequate freeboard causing further damage to embankment and pipework where already compromised at outlet.	See above.
