Department of Environment, Land, Water & Planning
Local Government Authority Dam Safety Program

South Gippsland Shire – Inspection Report

March 2018

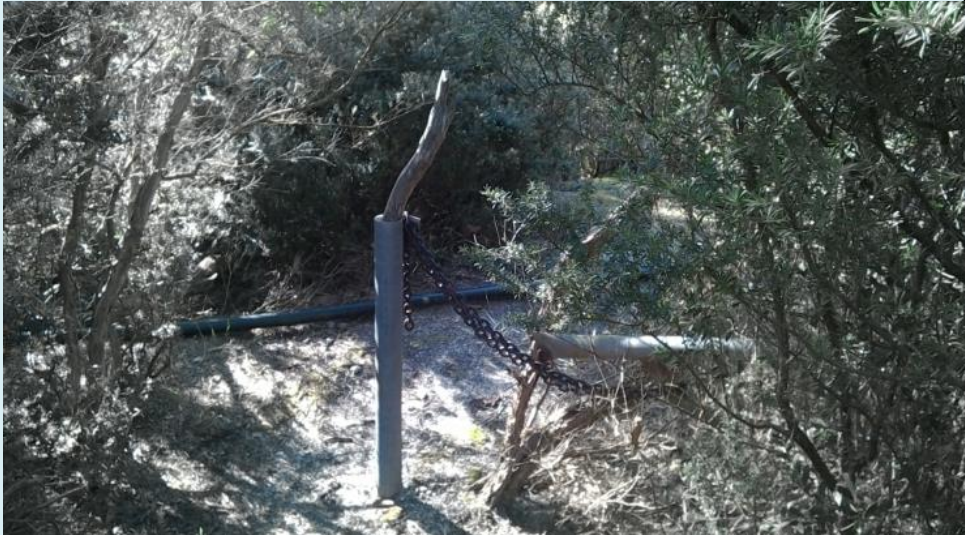
Type	Assessment
General site inspection details	
Site Name	Foley's Rd Dam
Locality	Yanakie
Map Reference (Coordinates)	Latitude = -38.816908 Longitude = 146.267568
Asset owner	South Gippsland
Describe access to site	Access from Foley's Road via a walking track through dense bush.
Photograph of site access	Damaged access gate.

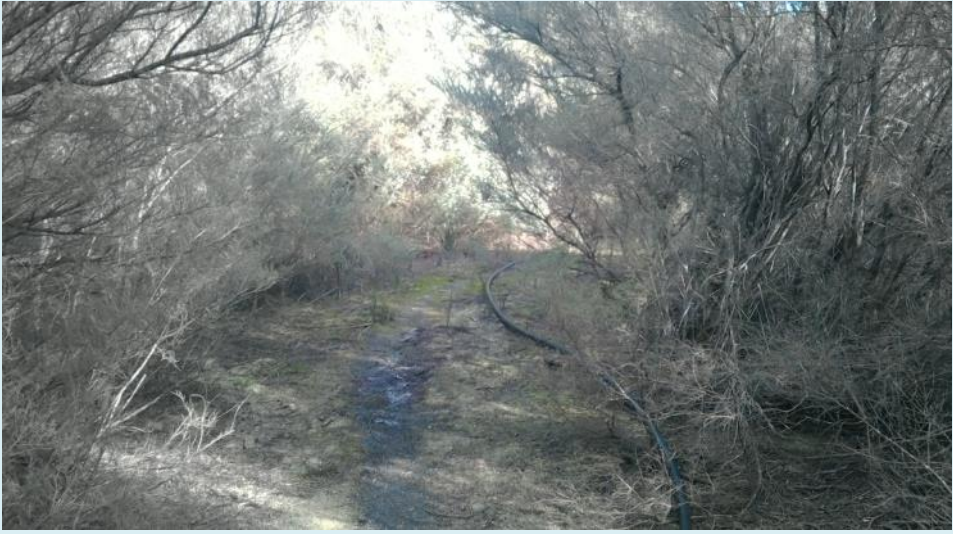
Type	Assessment
	<p>Access track through scrub to dam.</p>

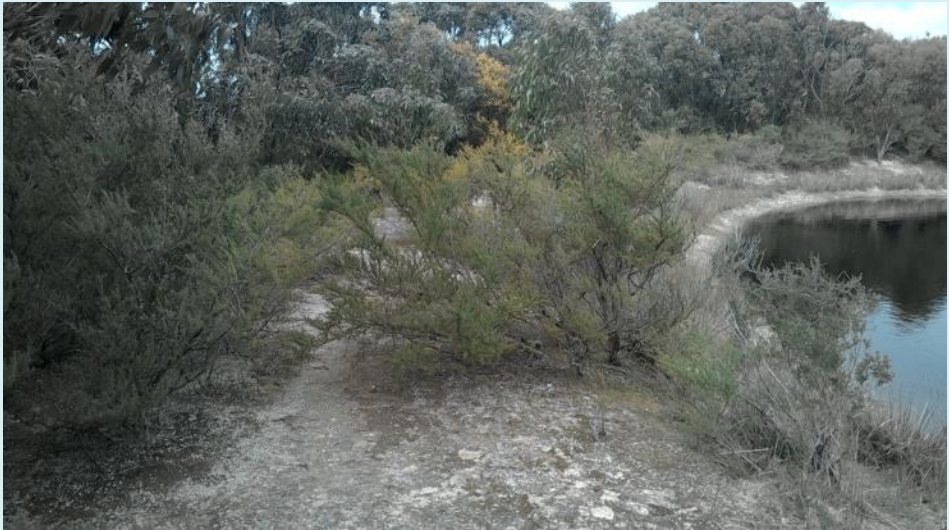
Type	Assessment
Determination from	Field inspection.
Downstream flood area	
Description	Eastward toward ocean. No PAR.
Determination from	Field inspection.
Dam Wall	
Construction type	Earthfill from site.
Upstream face type	Earthfill from site
Downstream face type	Earthfill from site (large boulders in d/s face).
Photograph of dam wall	<p data-bbox="496 972 1106 1003">Maximum section of dam looking south along crest.</p>

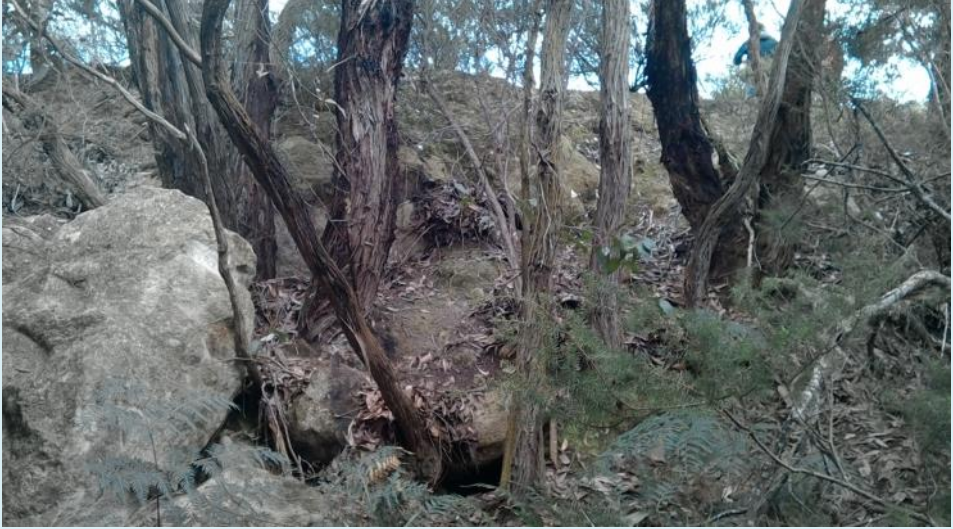
<p data-bbox="496 1561 1406 1592">Looking at d/s face from toe. Note non-homogeneous embankment material.</p>

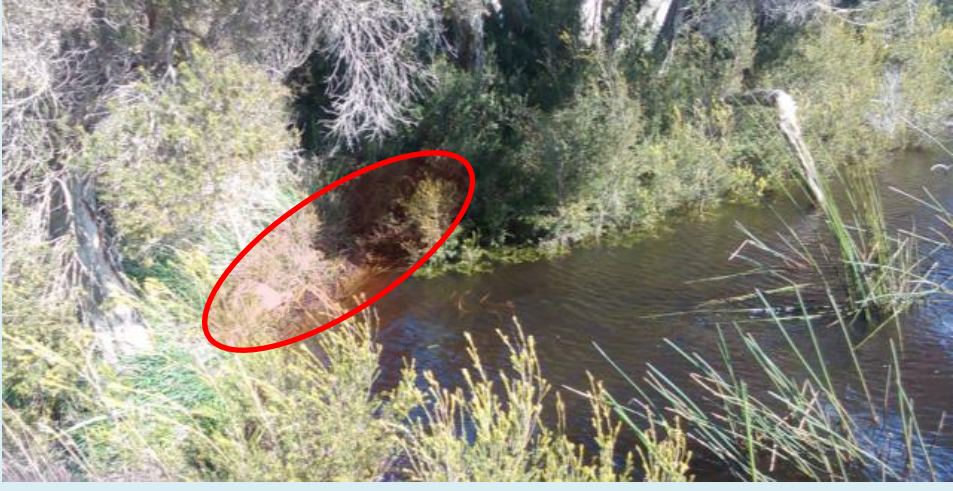
Type	Assessment
Inlet works (refer to drawings for more info)	
Size	1No. DN675 according to drawings (submerged during inspection).
Type	Grated mitred pipe with concrete headwall.
Inflow source	Prom Views Estate – Walkerville.
Photograph of inlet	Concrete headwall visible only (refer red outline) due to vegetation and storage level at time of inspection.

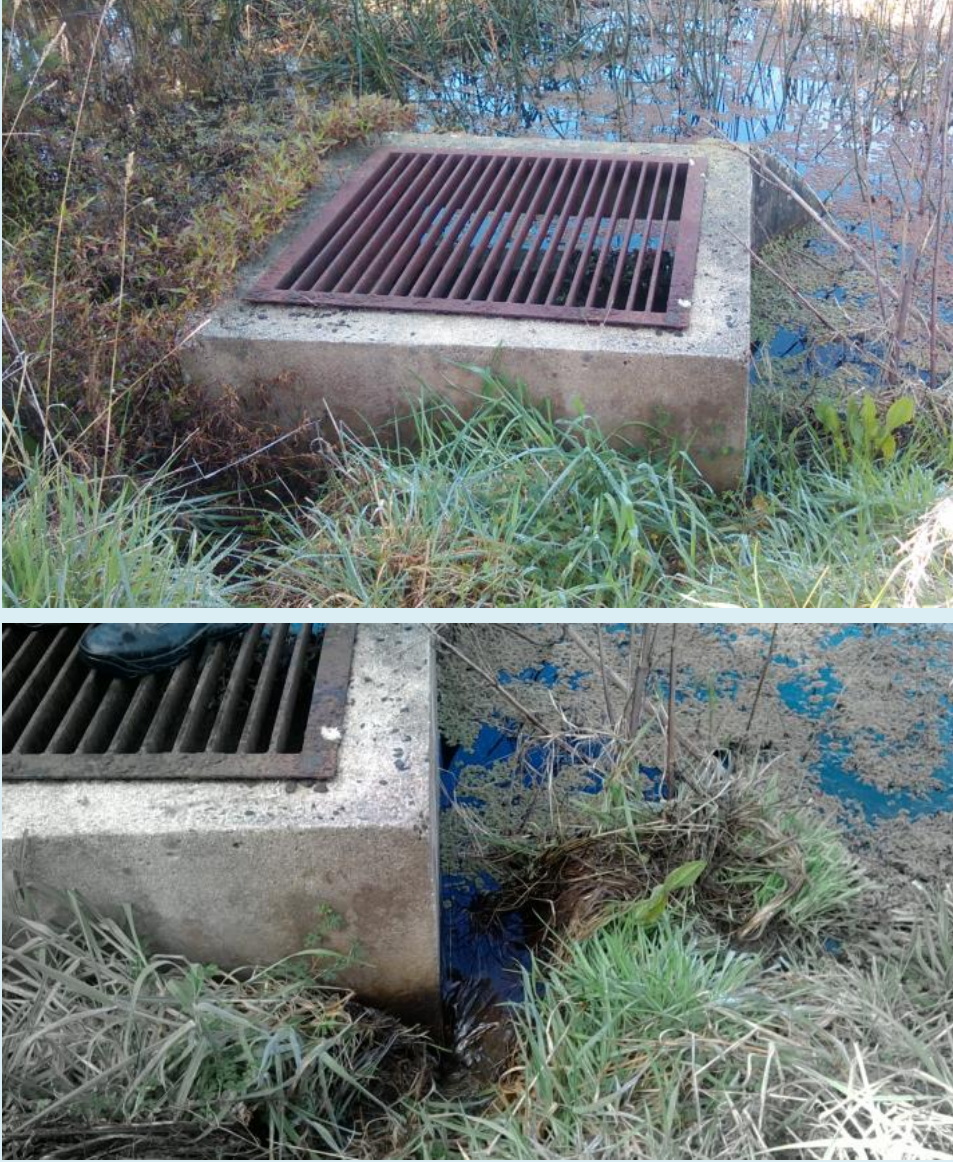
Spillway (refer to outlet works)	
Location	N/A.
Type	N/A.
Structure details	N/A.
Freeboard (m)	N/A.
Photograph of outlet	N/A.
Outlet works	
Size	Riser pit with 1 No. DN375 outlet pipe.
Detail	Urgent Investigation Required. Riser outlet acting as side entry pit. Steel grate lid to prevent gross litter blocking outlet pipe when acting as glory hole spillway. No discharge through riser outlet as leakage around outlet emplacement and

Type	Assessment
	<p>through embankment was occurring at time of inspection discharging via the outlet pipe (this indicates a break in the outlet pipe).</p> <p>Significant erosion around emplacement. Pipework exposed on u/s batter slope.</p> <p>Significant hole in crest offset ~0.5 m from outlet pipe alignment. Cause unknown but likely associated with leakage around outlet.</p>
Discharge reason	Stormwater excess
Photograph of outlet

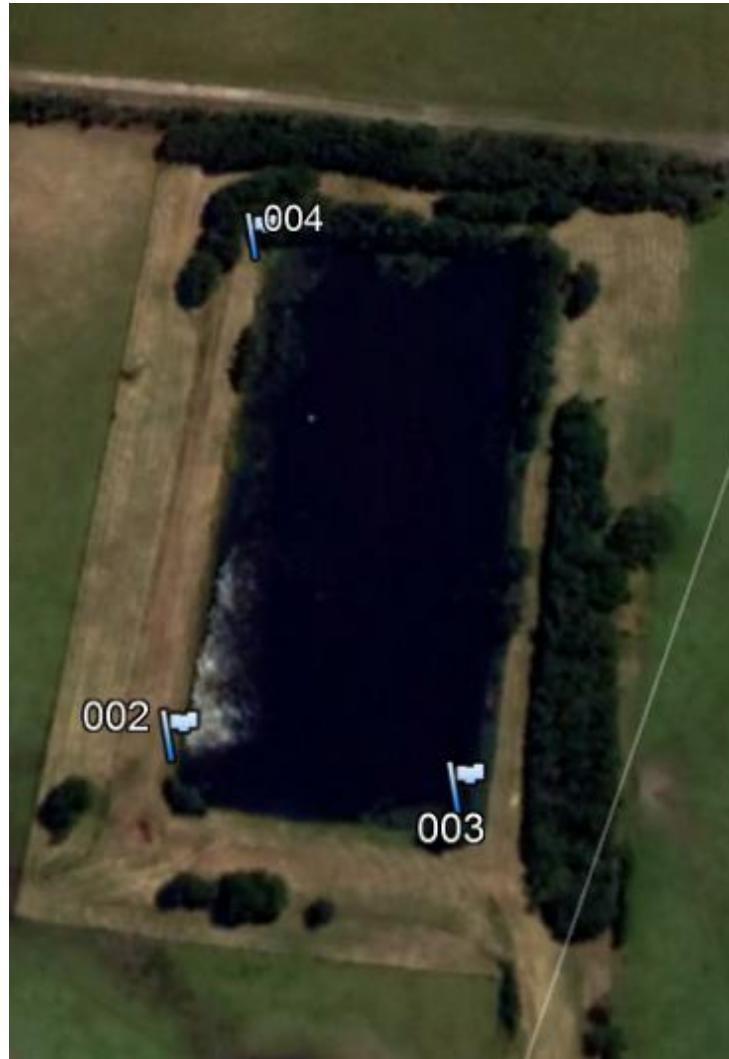
Figure 2: Walkerville Retarding Basin - Aerial view showing locations of interest

Key: 002 – Access stairway cut into upstream face of embankment, 003 – Inlet works, 004 – Outlet works.

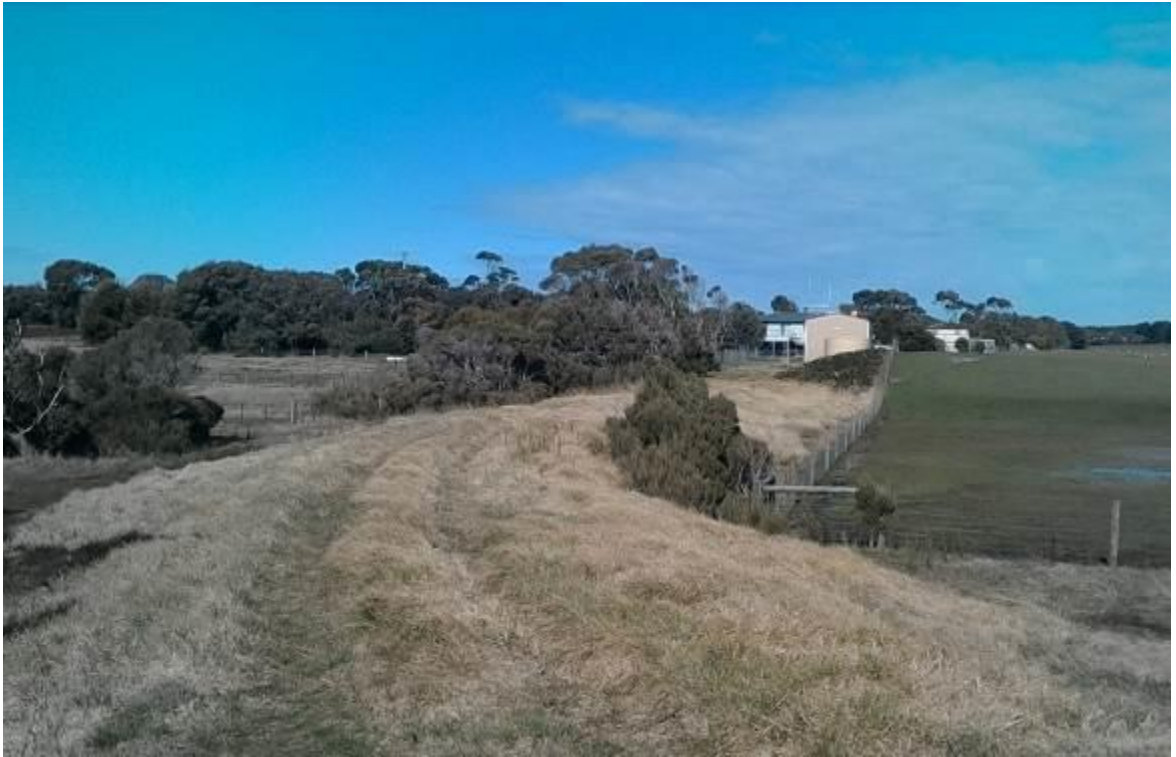
Figure 4: Walkerville RB – Looking south along access road toward CFA Station.

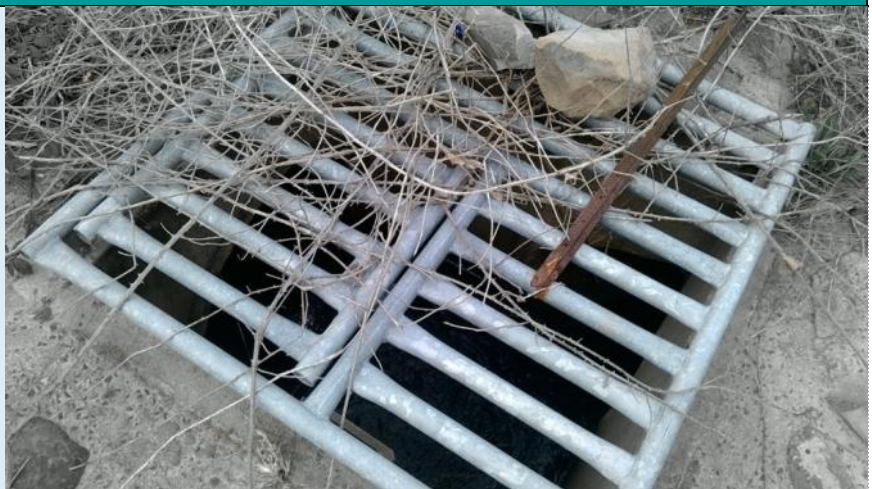
Spillway	
Location	N/A
Type	N/A
Structure details	N/A
Freeboard (m)	N/A
Photograph of outlet	N/A
Outlet works	
Size	1No. DN700 RC Pipe.
Detail	Soft around headwall.
Discharge reason	Stormwater discharge.
Photograph of outlet	Outlet pit

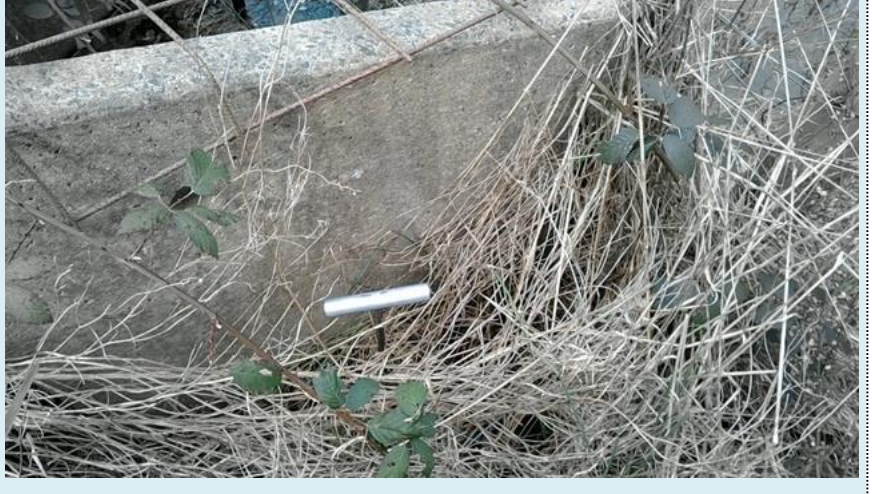
<p data-bbox="592 784 1468 828">Soft area beside outlet training wall (see probe penetration).</p>

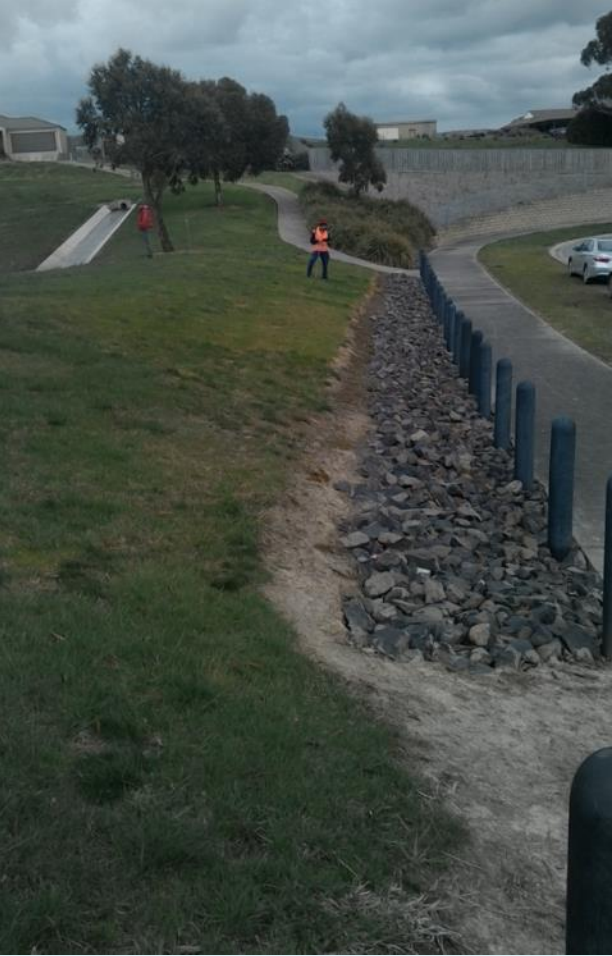
Downstream face type	Homogeneous earthfill with rock toe energy dissipation/ filtration strip.
