MARCH 2018

Water and sediment quality assessment Walkerville retarding basin

Final Report

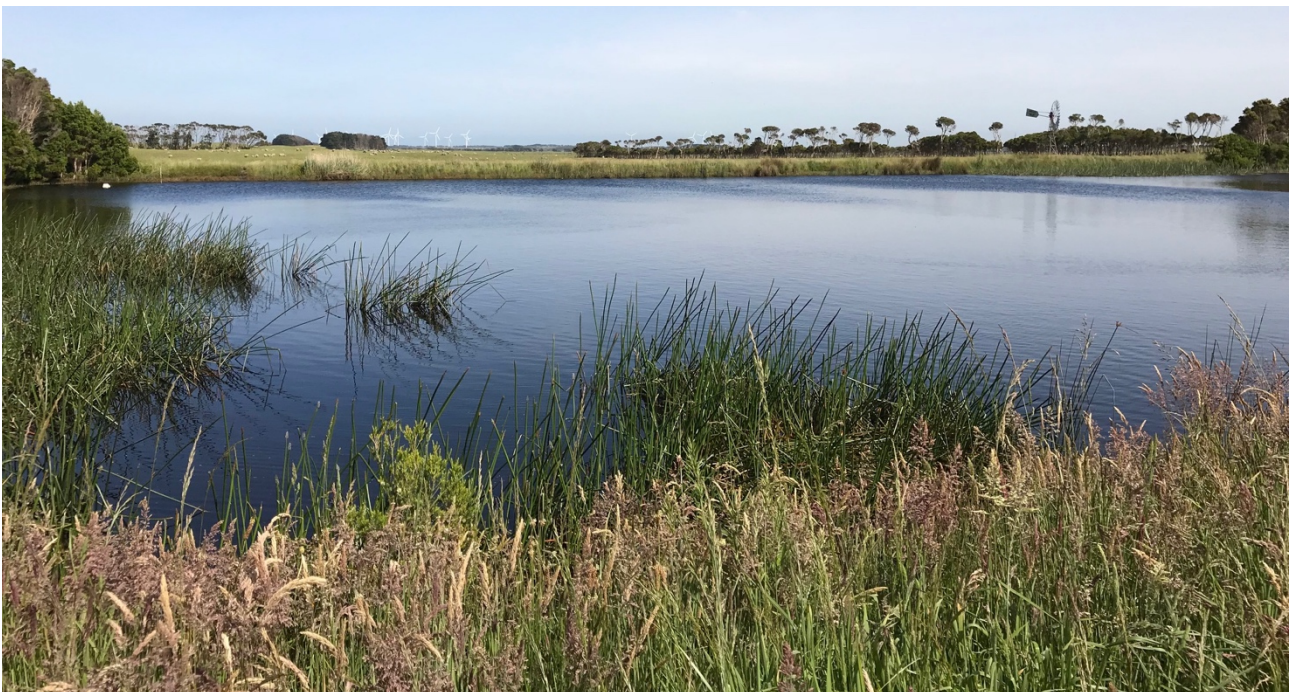
Figure 2-1: Walkerville stormwater retarding basin – 10 November 2017

Figure 2-1 shows a photo of the basin in November 2017. At the time of this site visit there was extensive weed and grass growth on the Council land surrounding the basin and reed growth particularly in the north-west and south-east corners of the basin itself. The water level in the basin was relatively high.

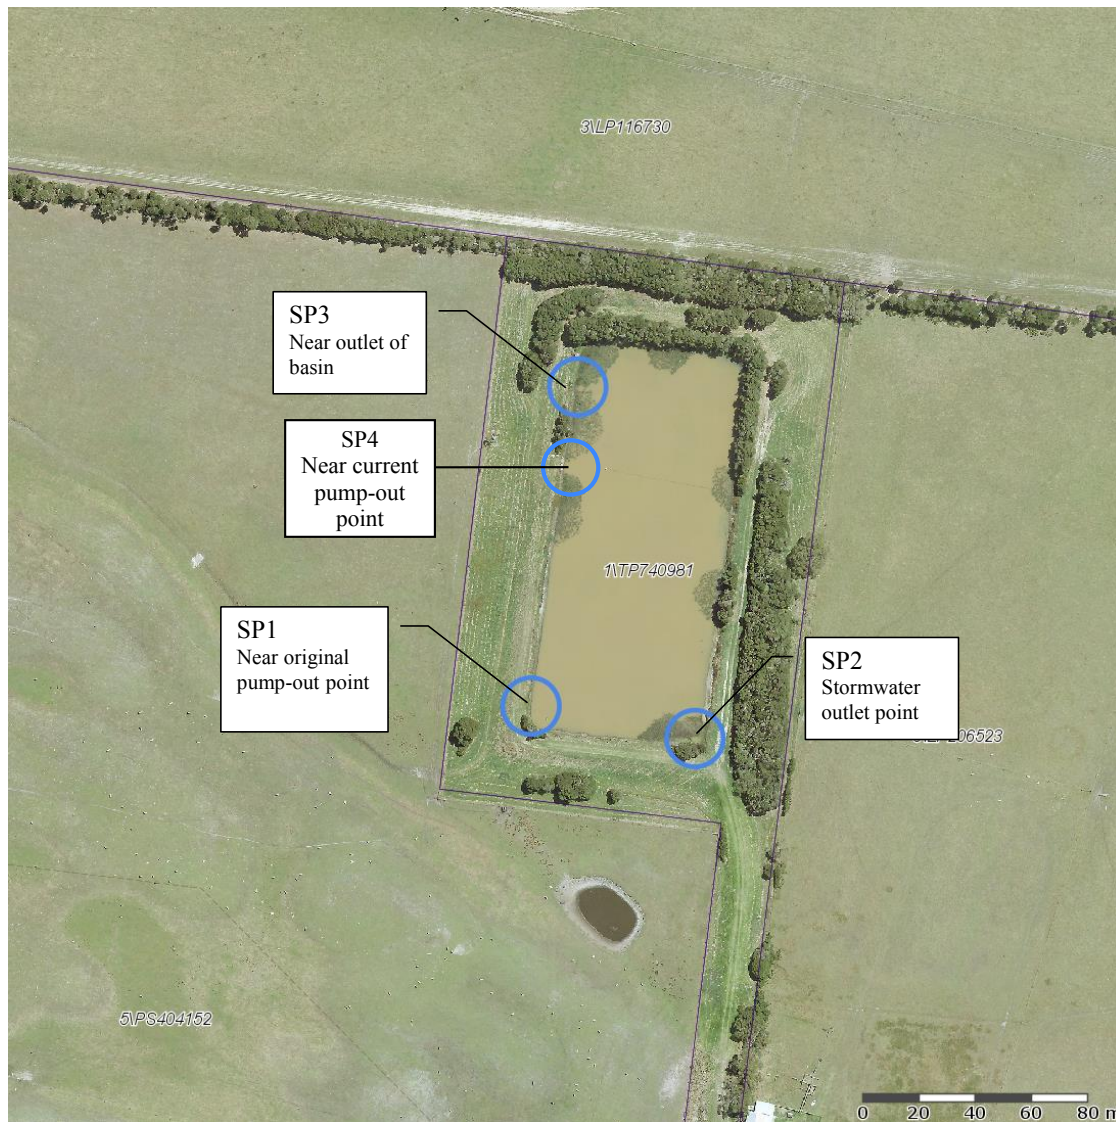
Figure 3-1: Basin sampling locations

Results have been compared to historical sampling and testing data provided by the South Gippsland Shire. Data is available from four monitoring sites at the basin, as shown on the map below. Water quality has been tested at various times at all four locations. Sediment quality has been tested at SP2, SP3 and SP4.

It is suggested that South Gippsland Shire continues with monitoring of *E. coli*, turbidity, pH, suspended solids and biological oxygen demand. This should be undertaken on regular basis – for example, monthly or bi-monthly. We recommend sampling at SP4 (refer to Figure 3-1) near the current pump out point.

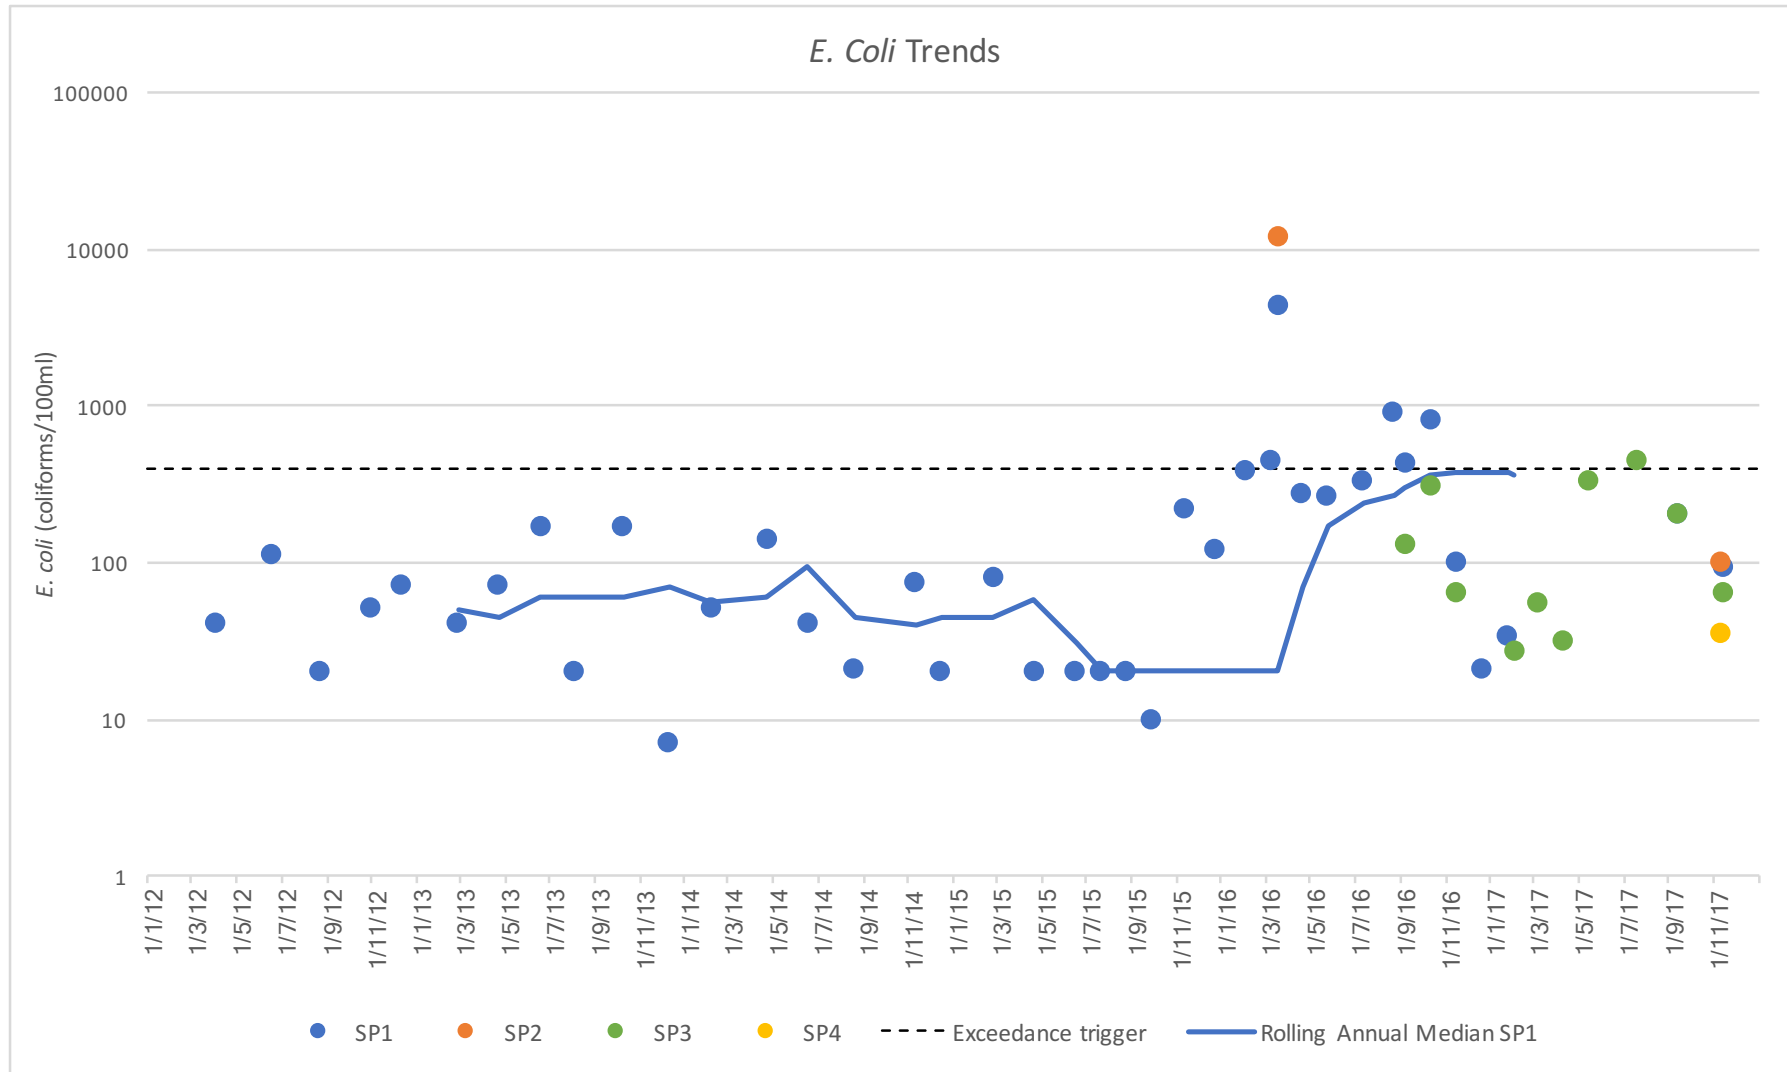
Figure 4-1: Monitoring results for *E. coli*

Monitoring results for *E. coli* are available since 2012. Results are graphed in Figure 4-1.

The ANZECC Water Quality Guidelines recommend that a median value of thermotolerant coliforms be used. A median value is based on a number of readings generated over a 12-month period from a regular monitoring program. The Guidelines state that investigations of likely causes are warranted when 20% of results exceed four times the median guideline level (400 orgs/100 ml *E. coli*.) in a 12-month period.

Prior to 2016, the sampling results indicated that *E. coli* levels did not exceed the guideline trigger. The median annual level remained below 100 orgs/100 ml *E. coli*.

In 2016, >20% of results exceeded 400 orgs/100 ml *E. coli* for Sampling Point 1. The rolling annual median for Sampling Point 1 also exceeded the guideline limit of 100 orgs/100 ml *E. coli* from May 2016 until early 2017 when regular monitoring at this point ceased.

In 2017, relatively regular monitoring was undertaken at Sampling Point 3. The median result during that calendar year was 63 orgs/100 ml *E. coli*.

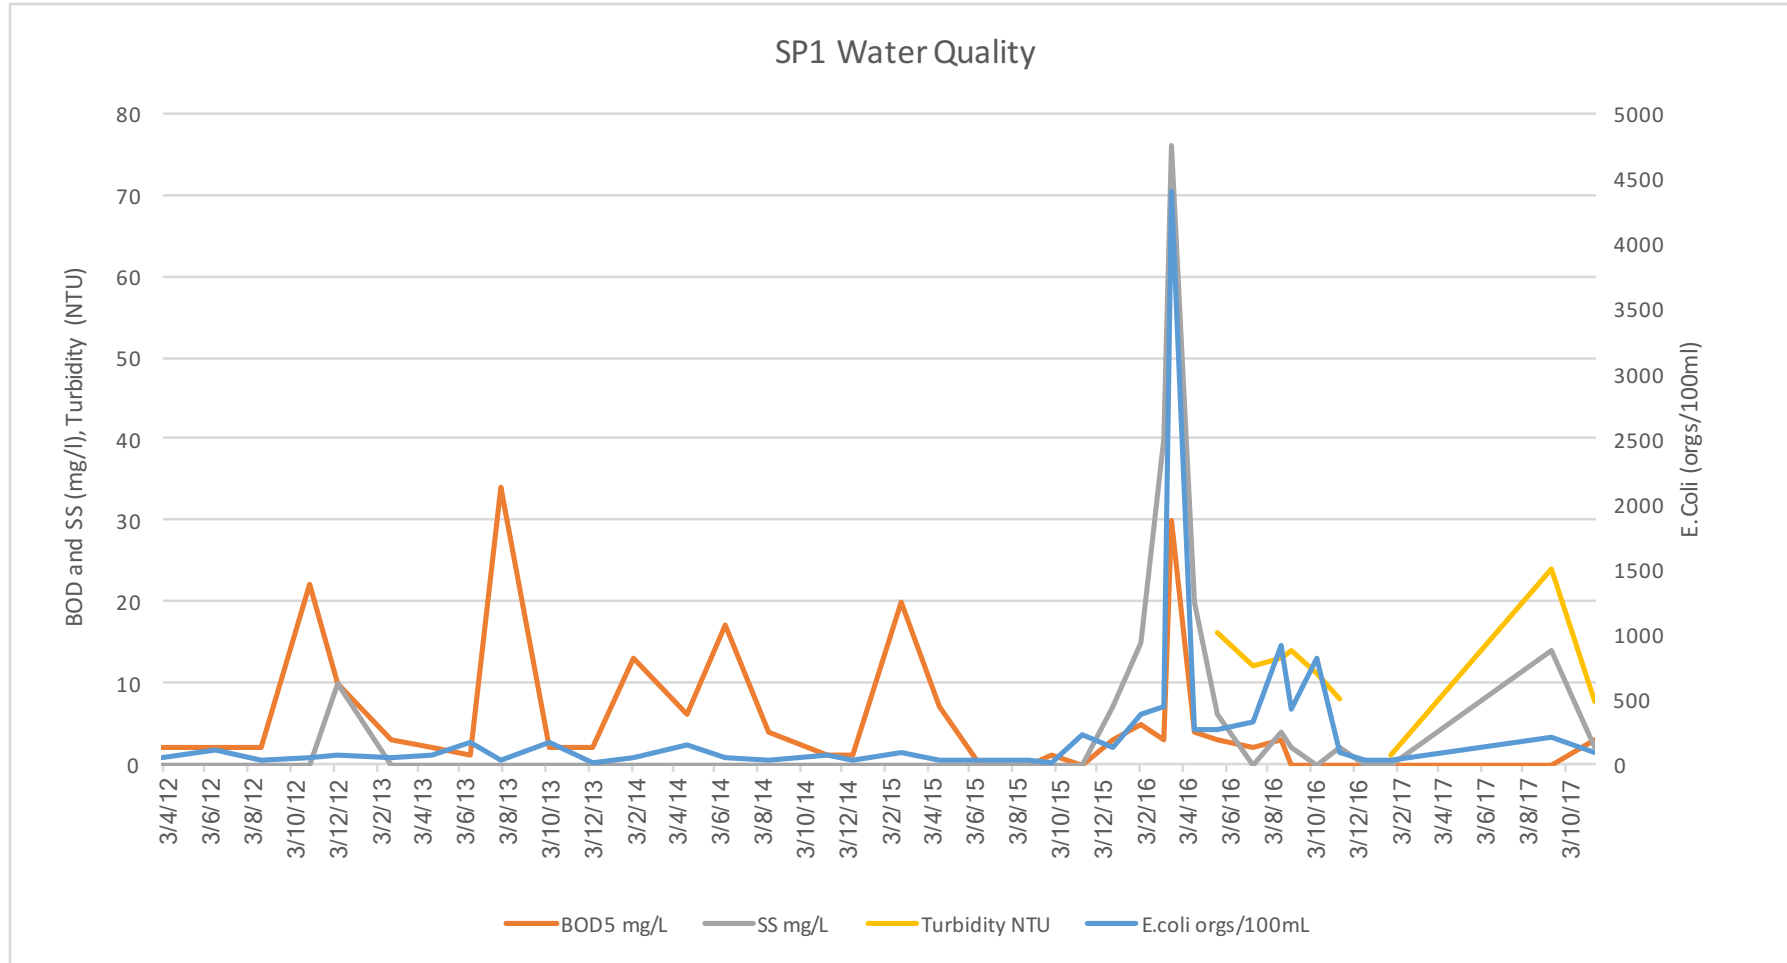
Figure 4-2: Comparison of Monitoring Parameters at SP1

For Sampling Point 1, which has the most data available, comparison has been made between *E. coli* and other available monitoring data (including turbidity, pH, biological oxygen demand (BOD) and suspended solids (SS)), refer to Figure 4-2.

There is no clear correlation between *E. coli* results and the other parameters, with the exception of a corresponding spike in BOD, SS and *E. coli* in March 2016.

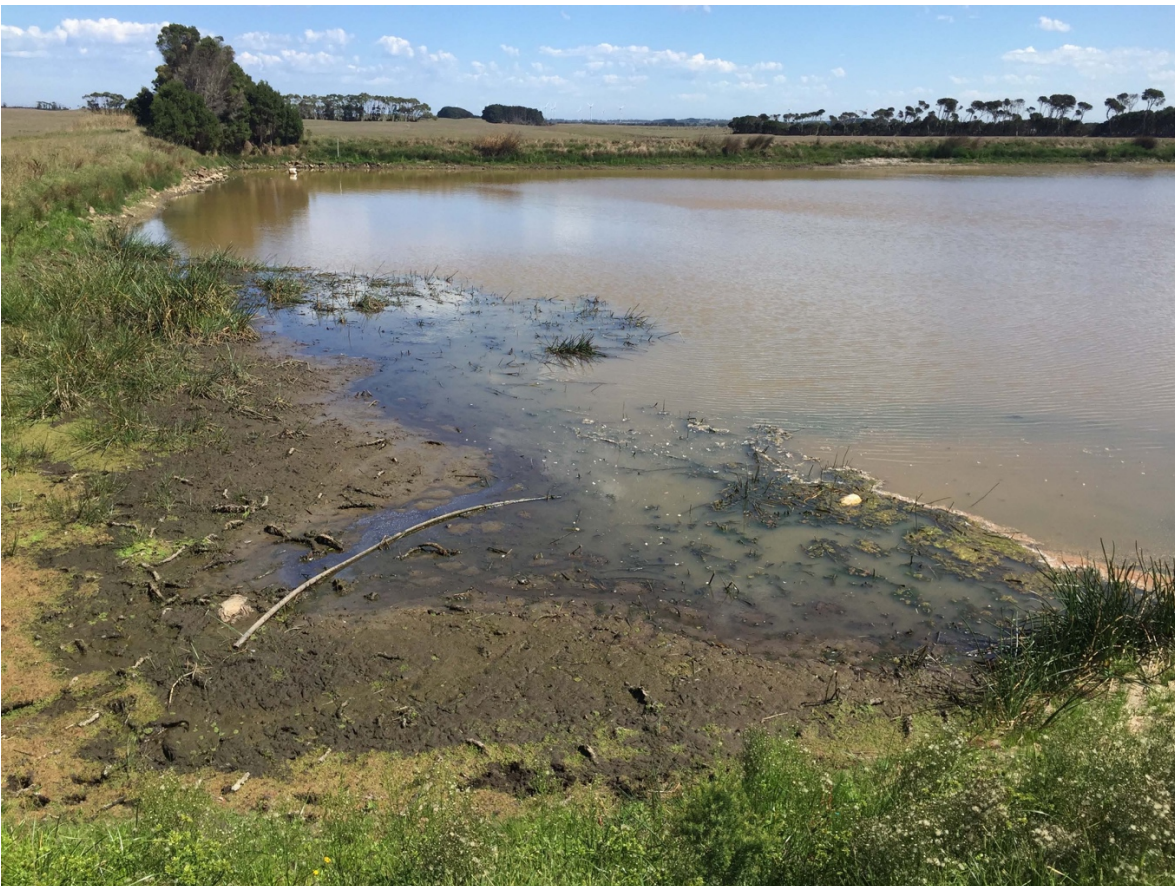
Figure 4-3: Walkerville stormwater retarding basin – 2 March 2016

South Gippsland Shire noted that there may be a correlation between water depth and water quality (Tim Brown and John Lambert, South Gippsland Shire, pers. comm., 10/11/17). Depth in the basin is not recorded at the time of sampling. However, photos are generally taken of the basin, so approximate depth can be inferred from these. When the basin water level is very low, the sediment is more likely to be mobilised into the water column through wind and wave action. This would increase turbidity and suspended solids levels as shown in the following photo – the water is looking “muddy”. However, the correlation with *E. coli* is less clear. It is recommended that water levels are monitored when *E. coli* is sampled in future – refer to Section 8 for further details.
