## LGA Dams – Site inspection methodology, general asset information & inspection checklist

<b>Asset name:</b>	Walkerville RB
<b>Locality:</b>	Cnr Grevilla St & Panoramic Dr, Walkerville
<b>Local government region:</b>	South Gippsland
<b>Date of inspection:</b>	23 August 2017
<b>Inspection team:</b>	Ryan Glen, David Roche (SGSC) Greg Branson, Joe Matthews, Richard Mannix (SRW)
<b>Weather conditions:</b>	Cloud with some sun. Windy.
<b>Temperature:</b>	12°C

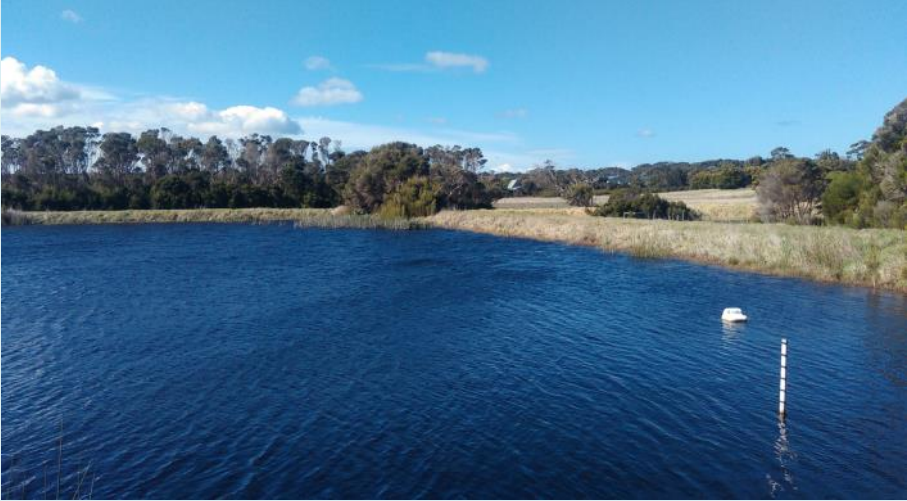
Type	Assessment
Photograph of inlet	Concrete headwall visible only (refer red outline) due to vegetation and storage level at time of inspection.

Type	Assessment <sup>1</sup>	Detail	Recommendation	Urgency Rating <sup>2</sup>	Importance Rating <sup>3</sup>
<b>Inlet works</b>					
General condition	N/A	Not sighted due to storage level at time of inspection.	Remove vegetation around inlet structure.	Short term action	High
<b>Other comments/ observations</b>					
Freeboard and outlet adequacy.		Large rainfall event could cause outlet pit trash screen to block and RB to overtop due to inadequate freeboard causing further damage to embankment and pipework where already compromised at outlet.	See above.
