Proposed works at Walkerville Retarding Basin

1.1 We **enclose** by way of service copy of a report of Mr David Stewart – Australian Dams and Water Consultants Pty Ltd dated 30 April 2018.

SOUTH GIPPSLAND SHIRE COUNCIL
WALKERVILLE BASIN
EXISTING CONDITIONS
SCHEMATIC

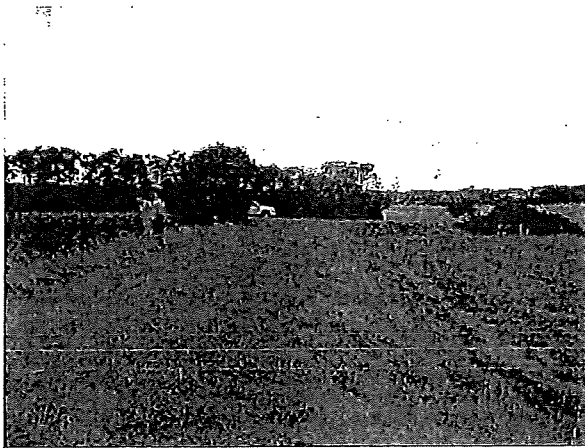
Photo 01

- The water level at the time of the inspection was not provided, but was well below full supply level.
- The condition of the embankments and crest were generally good. Some minor depressions were observed, however, all areas of the crest were accessible and trafficable using a regular light vehicle (Photo 01).

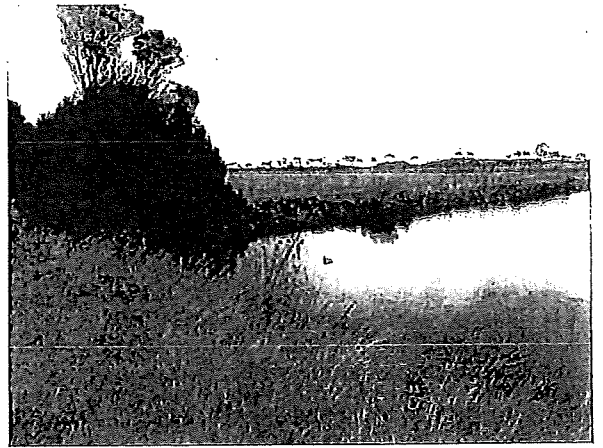
Photo 02

- There were a number of mature trees growing through the embankments. It is recommended trees and shrubs be removed from the embankments to prevent the development of piping pathways via root zones (Photo 02).

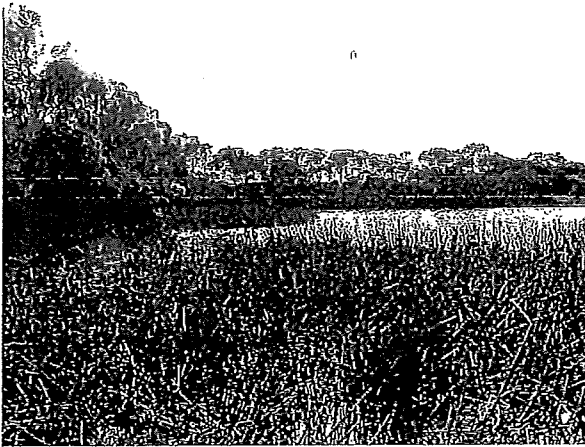
Photo 03

- Heavy reed growth was observed around the basin rim (Photo 03). Vegetation should be managed as it can restrict inflows and outflows.
- Minor cracking and spalling of the concrete overflow structure (spillway) was observed, however the overall condition was generally sound (Photo 04). No visible signs of settlement or leakage around the structure could be observed. However, it was understood that water levels have been low for some time, as such, any possible leakage pathways were difficult to identify.

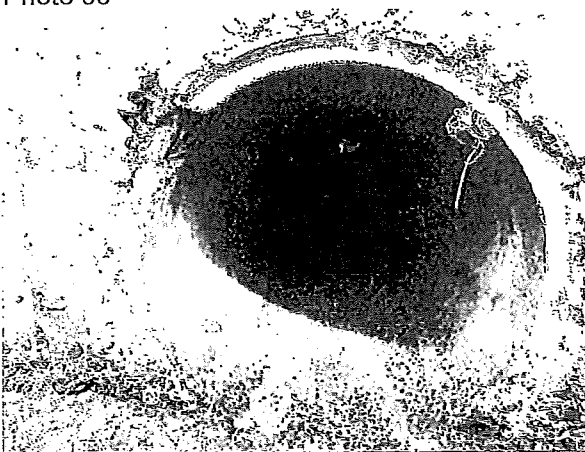
Photo 05

- Despite minor concrete spalling, the general condition of the overflow outlet pipe was sound and clear of blockages (Photo 05).
- Backfilling around the overflow pit was sporadic and not tight against the pit (Photos 06 and 07). This is likely to be affecting the performance of the structure and foundation and may be providing pathways for leakage when water levels are higher than at present.

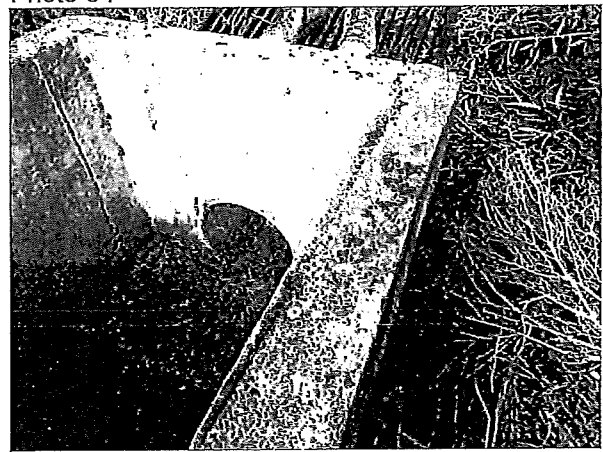
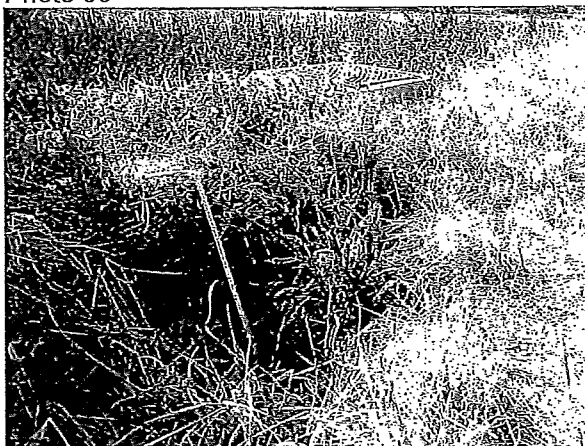
- Backfilling immediately around the overflow structure was sporadic and is likely to be affecting the performance of the structure and foundation. This may lead to leakage around the structure when water levels are higher than observed during the site inspection (hence, a lower full supply level).

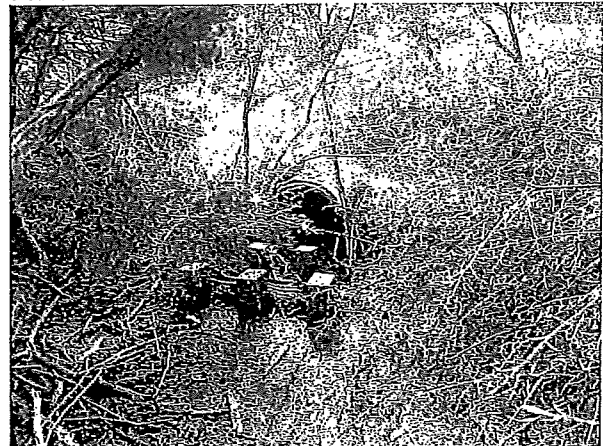
Photo 08

- Downstream, the spillway outlet should be cleared so any flow can pass unimpeded (Photo 08).
- The inlet was below the water line and could not be observed.

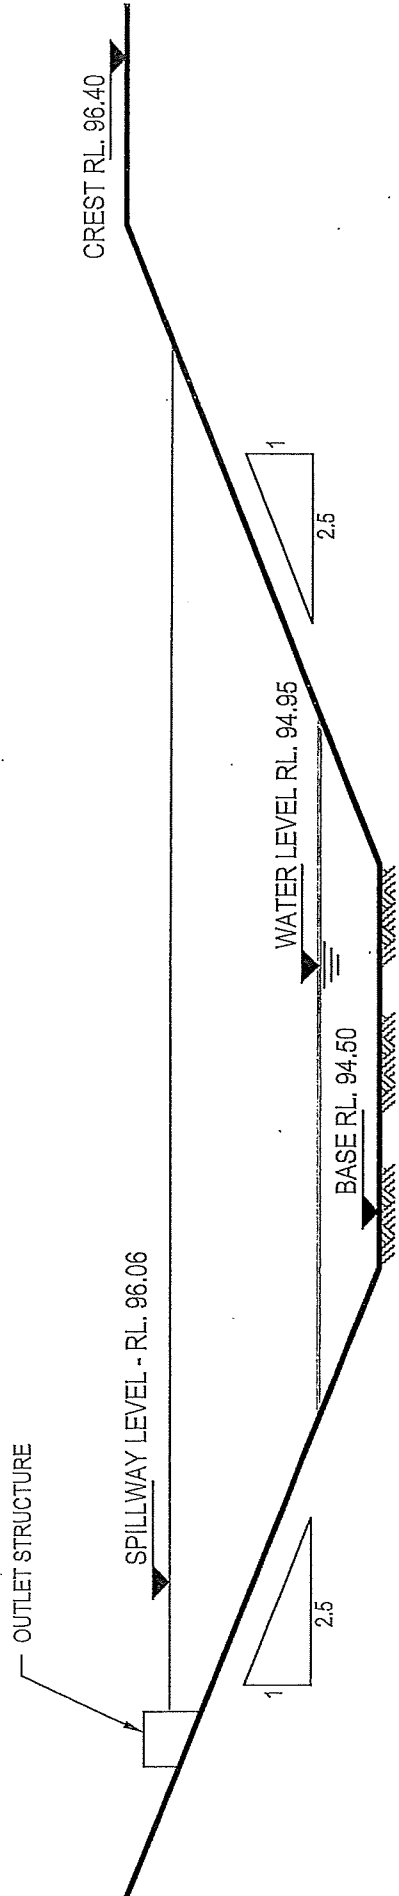
GHD have completed a three-dimensional assessment of basin volume at various water levels using the survey data provided. The results show that at full supply level (FSL) of RL 96.06 m (current overflow level) the maximum storage volume is 13.2 ML (Table 2). Figure SK-01 is a schematic showing basin conditions.
