Department of Environment, Land, Water & Planning
Local Government Authority Dam Safety Program

South Gippsland Shire – Inspection Report

March 2018

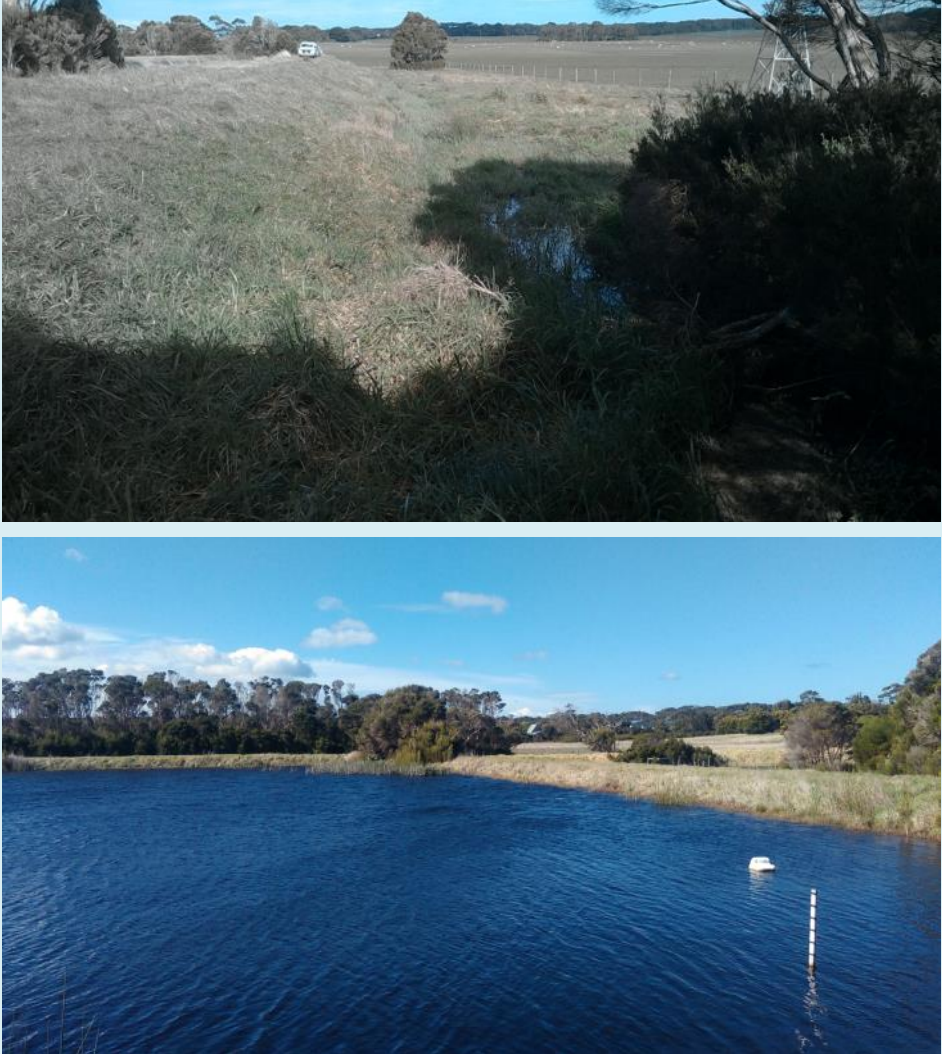
Type	Assessment
Photograph of dam wall

Crest length (m)	Northern and southern crest lengths ~65.0 m Eastern and Western crest lengths ~150.0 m
Crest width (m)	Northern and southern crest width 4.2m Eastern and Western crest width 3.5m
Surface area at FSL (m ²)	~ 10,500 m ²
Upstream slope (V:H or %)	RB at FSL so couldn't be measured. According to drawings: 1V:2H.
Downstream slope (V:H or %)	25% or 1V:4H.
Height at maximum section (m)	3.50 m field altimeter test at southern embankment.

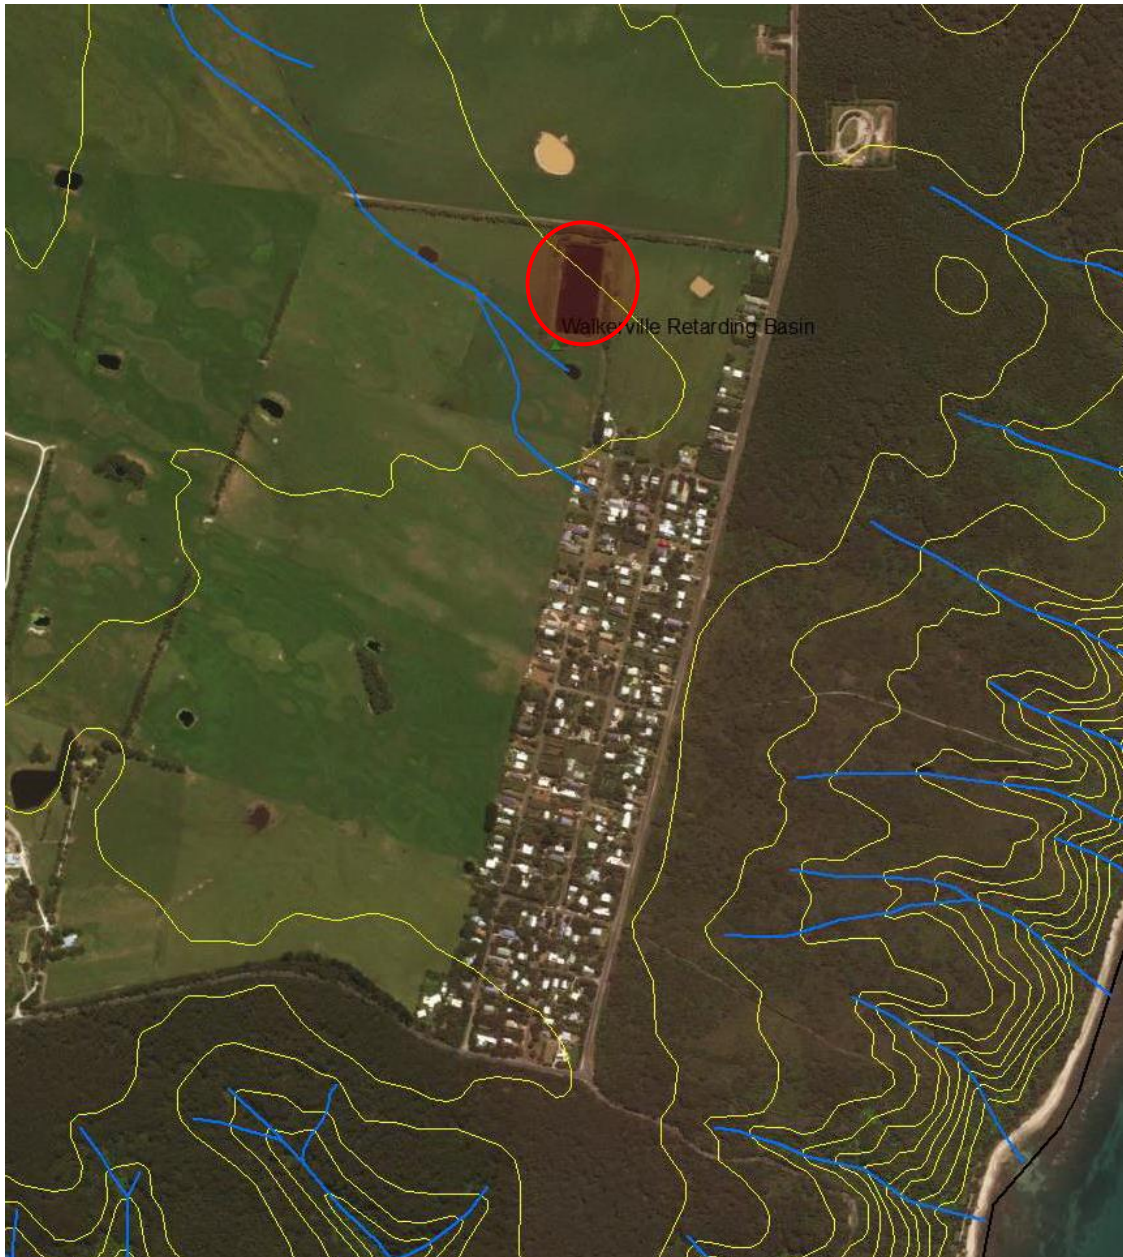
Figure 3: Walkerville Retarding Basin - Aerial Site View

Key: 002 – Access stairway cut into upstream face of embankment, 003 – Inlet works, 004 – Outlet works.

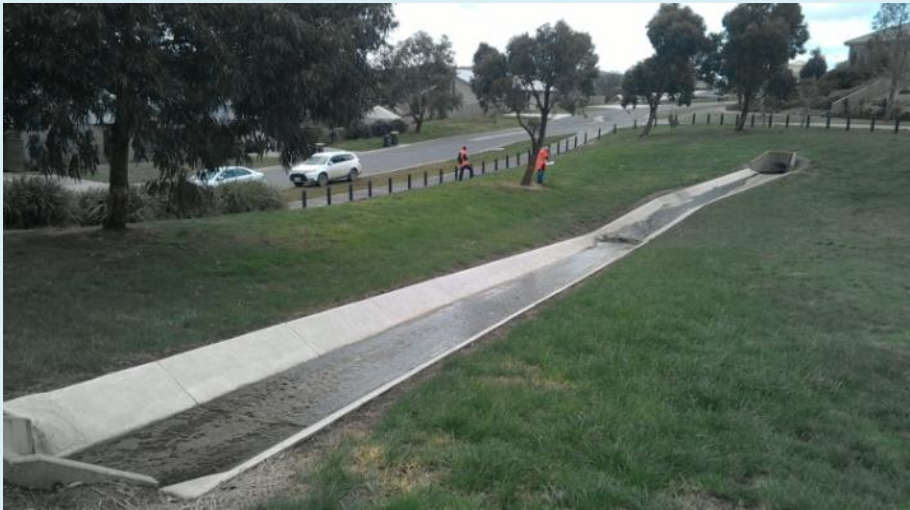
Type	Assessment
General site inspection details	
Site Name	Hannah Rise Crescent RB
Locality	Korumburra
Map Reference (Coordinates)	Latitude = -38.440007 Longitude = 145.813432
Asset owner	South Gippsland Shire
Describe site access	Retarding basin is public open space recreation area. Accessible from all sides via Lauren Way and Hannah Rise Crescent.
Photograph of site access
