Slope Stability Assessment

**No. 99, Bena Road, Korumburra,
Victoria, 3950**

175232-PRJ75208-GEO-REP 01

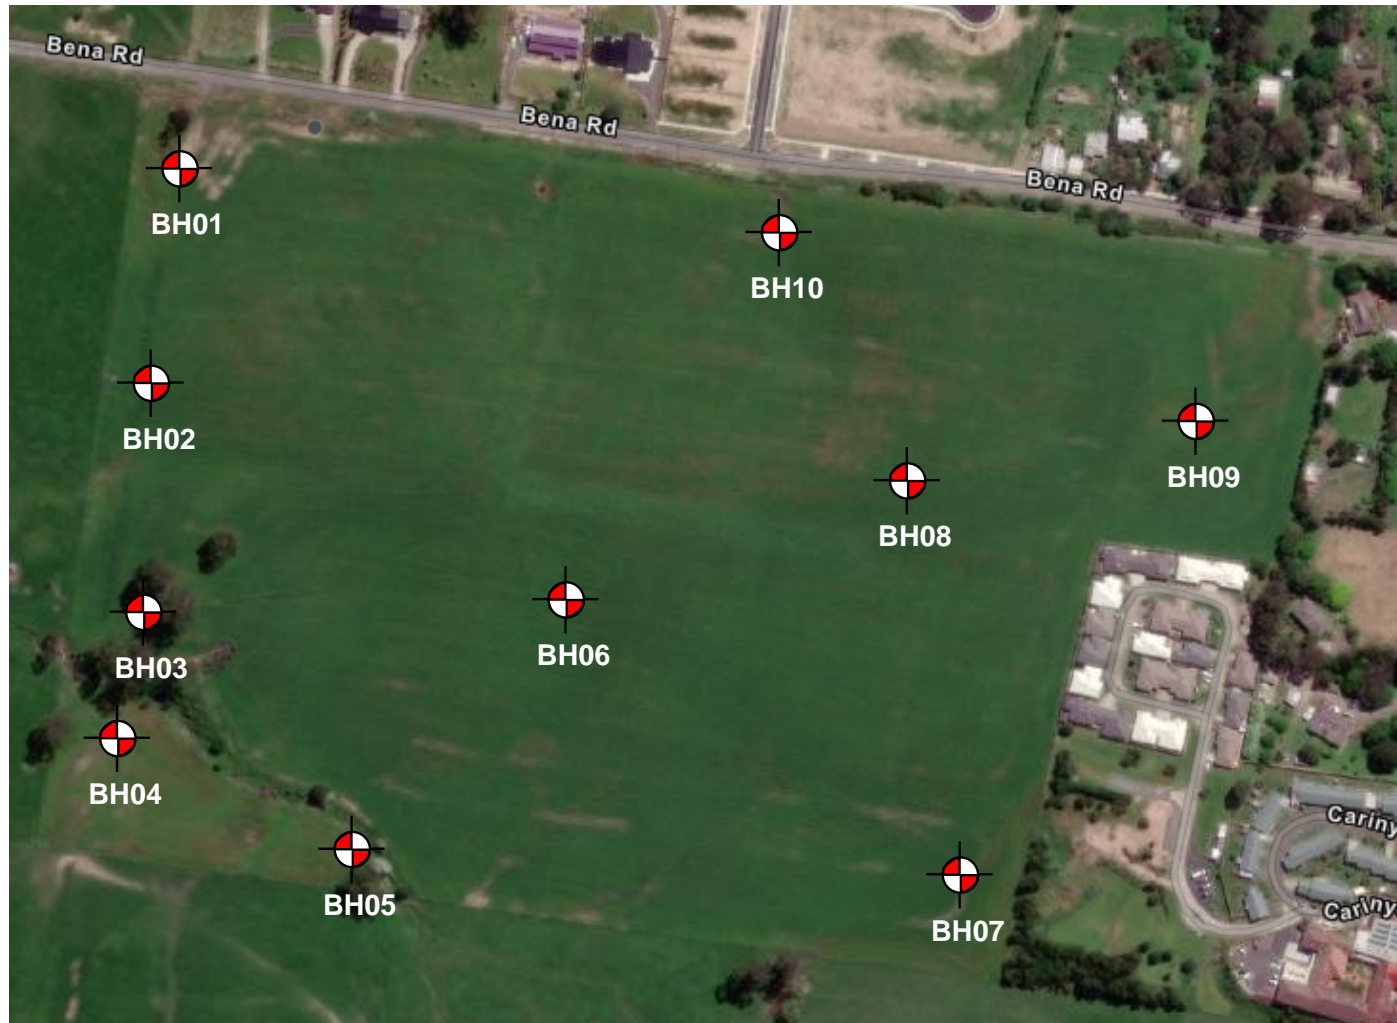
Site Plan and Borehole Logs

<p>Intrax GROUP</p> <p>Civil Forensic Hydraulic Structural Surveying Residential Geotechnical Building Services</p> <p>Level 4/469 La Trobe Street, Melbourne, VIC 3205 EMAIL: info@intrax.com.au PHONE: 1300 INTRAX FAX: 61 3 8222 0199 A.B.N. 31 106 481 252 www.intrax.com.au</p> <p><small>© This drawing is copyright to Intrax Consulting Engineers, no part of this drawing shall be used for any other purpose without the prior written consent of Intrax Consulting Engineers.</small></p>	<p>Client: Hillview Rise c/o Brosnan Engineering Solutions</p> <p>Project: No. 99, Bena Road, Korumburra, VIC, 3950</p> <p>Drawing: Site Plan</p>
