SITE MANAGEMENT PLAN ACTIONS

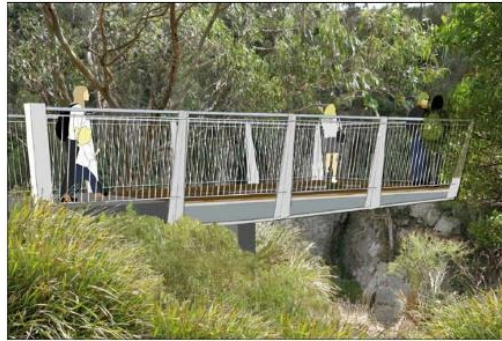
PHOTO 1: PROPOSED CANTILEVERED LOOKOUT BELOW FALLS

- 20 Construct new cantilevered lookout structure and handrail infill
- 21 Upgrade east viewing area path surface, grading and drainage and maintain timber retaining walls
- 22 Retain closed unsealed access track for future construction access of lookout. Potential area to install new picnic tables in the future if required

FALLS LOOKOUT ZONE
 Construct new cantilevered lookout over the falls including path and handrail upgrade works to create a major new visitor attraction. Land to be managed primarily for recreation access with minor vegetation removal works to allow for construction of the lookout.

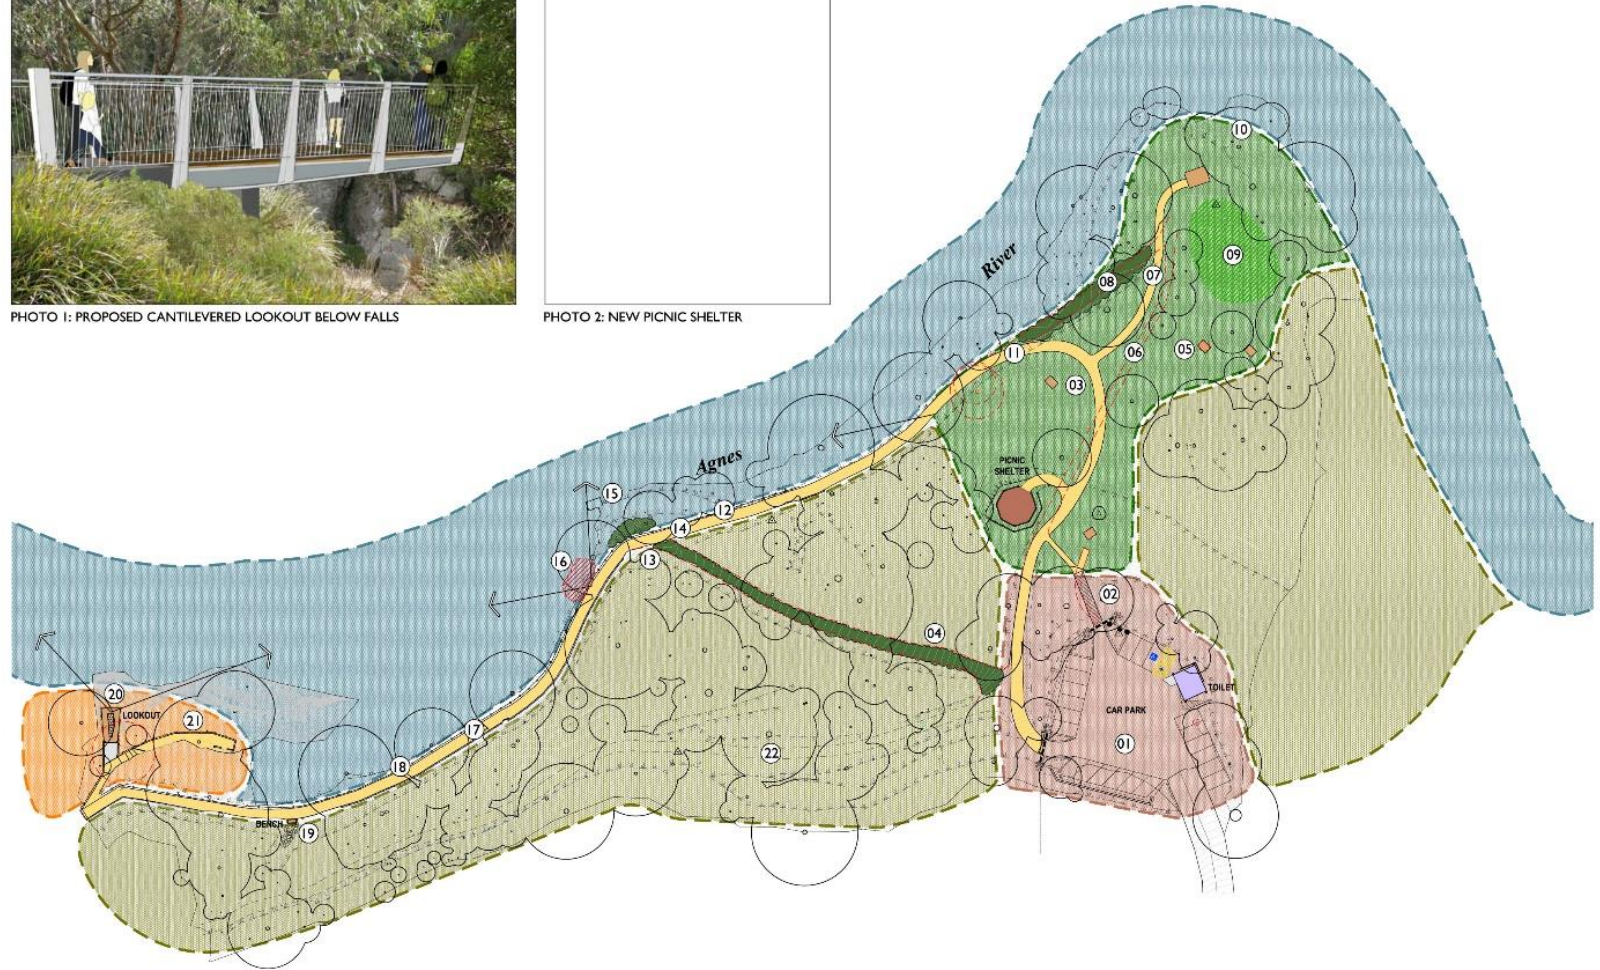
MANAGEMENT ZONES KEY

VISITOR ENTRY & CAR PARK ZONE
 Future upgrade of car park including reconfiguration of parking layout to accommodate approximately 20 car spaces and 1 disabled space and to allow for long vehicle turnaround. Minor earthworks and surface grading to capture drainage with garden bed/WSUD planting. Upgrade pedestrian entry points from the car park to provide better defined access points to the reserve.

PICNIC & RECREATION ZONE
 Land to be managed primarily for recreation access with facilities including a new picnic shelter, interpretive signage, picnic tables, improved open mown grass areas and new walking paths. Retain existing sparse native overstorey trees and slashed grass understorey with limited revegetation to retain clear sightlines and reduce risk of falling limbs in picnic areas.

RIVER/WATERS EDGE PROTECTION ZONE
 Land to be managed for protection of water quality and river health for the South Gippsland Water Catchment Management Authority including protection of banks and formalise and restrict public access back from waters edge. Undertake revegetation of degraded river banks to enhance river environment values, and retain key viewlines to the river, top of falls and new lookout through appropriate vegetation management.

NATURAL BUSHLAND ZONE
 Land to be managed for existing natural environment, habitat and vegetation values without recreation access.
